Joshua Moraal, Jeff Doucette, Seth Stevens

# Protecting Water from Water: Assessing Braided System Bank Erosion Threatening Water Supply in a Mediterranean Climate

8<sup>th</sup> Conference on Natural Channel Systems

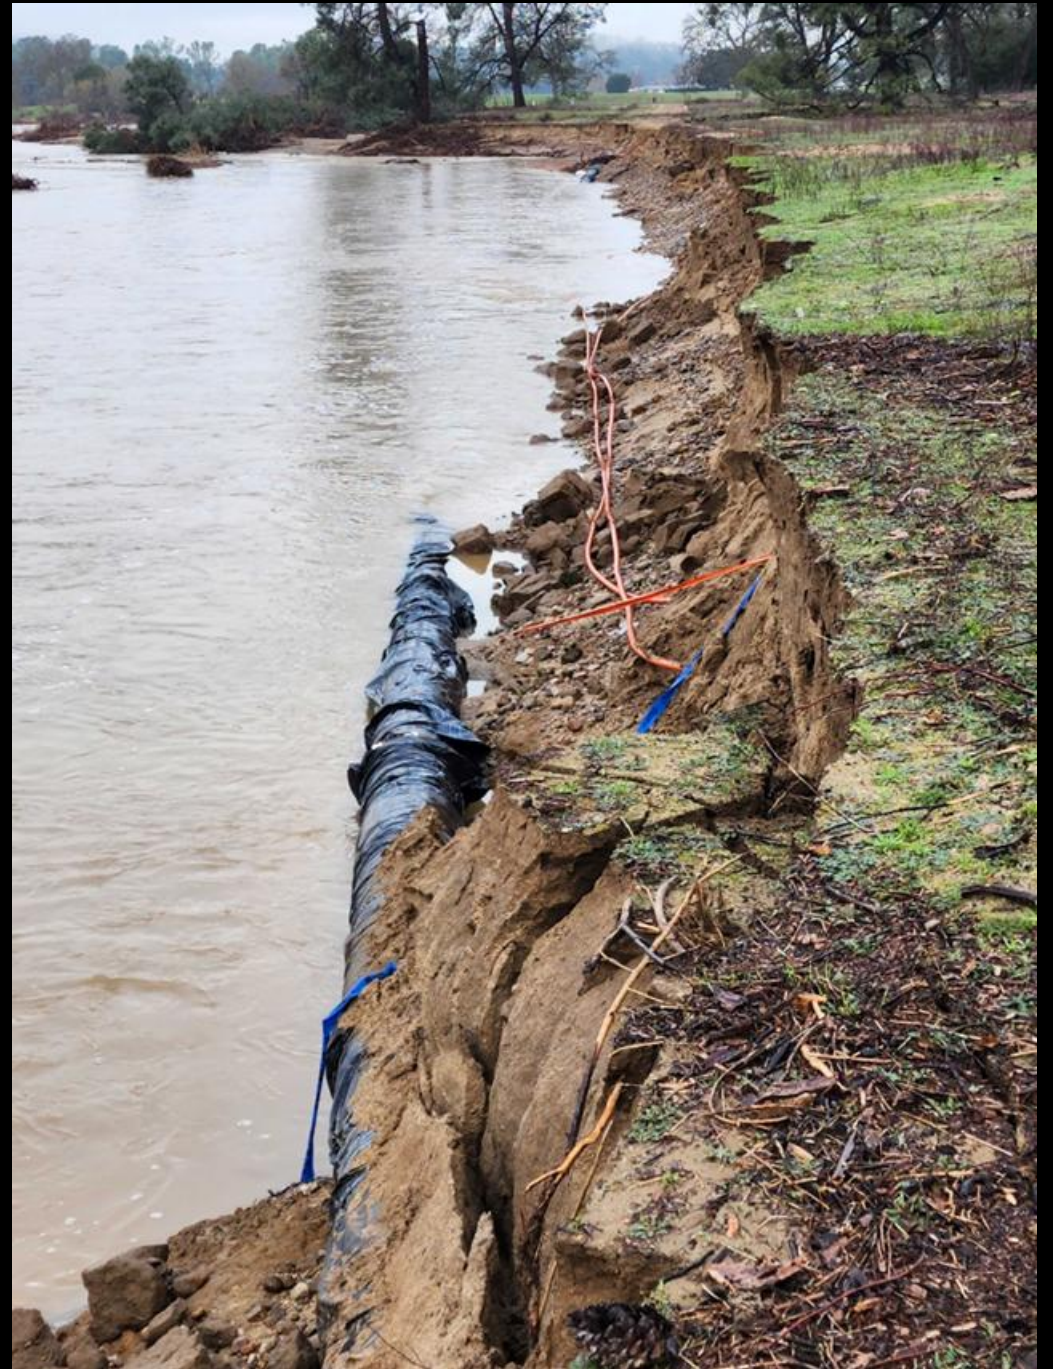
# January 9, 2023 Storm

Intense rainfall led to widespread flooding throughout SLO County

Highest Rainfall in 25 yrs

350 m<sup>3</sup>/s flow

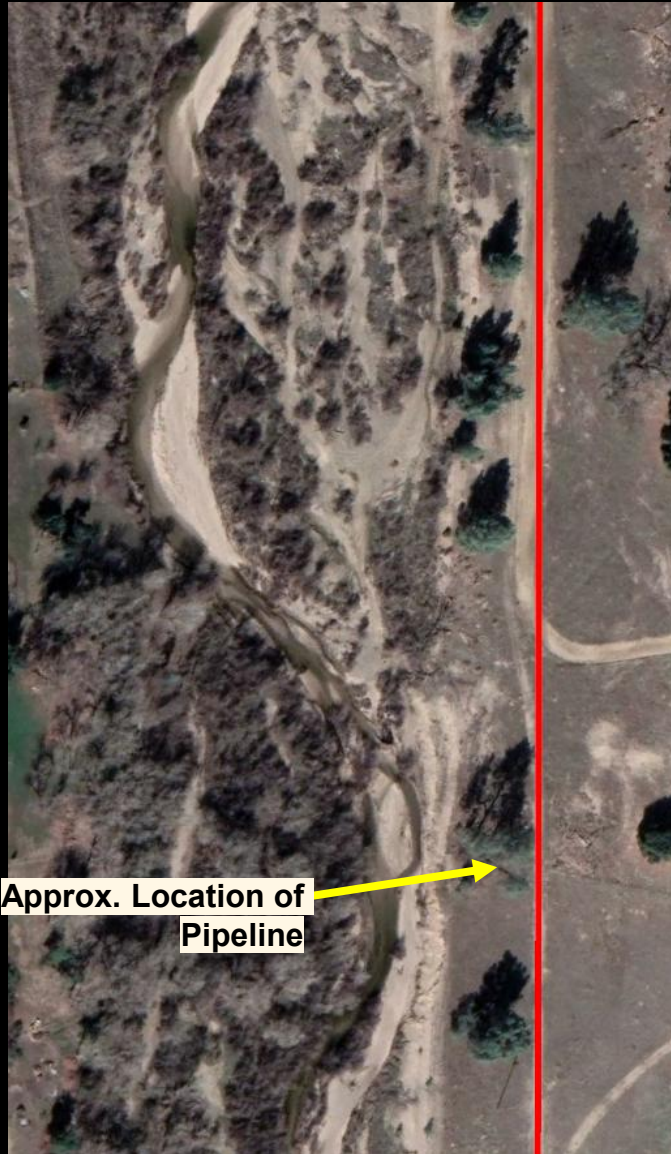
February 2021

# Nacimiento Water Pipeline Damage

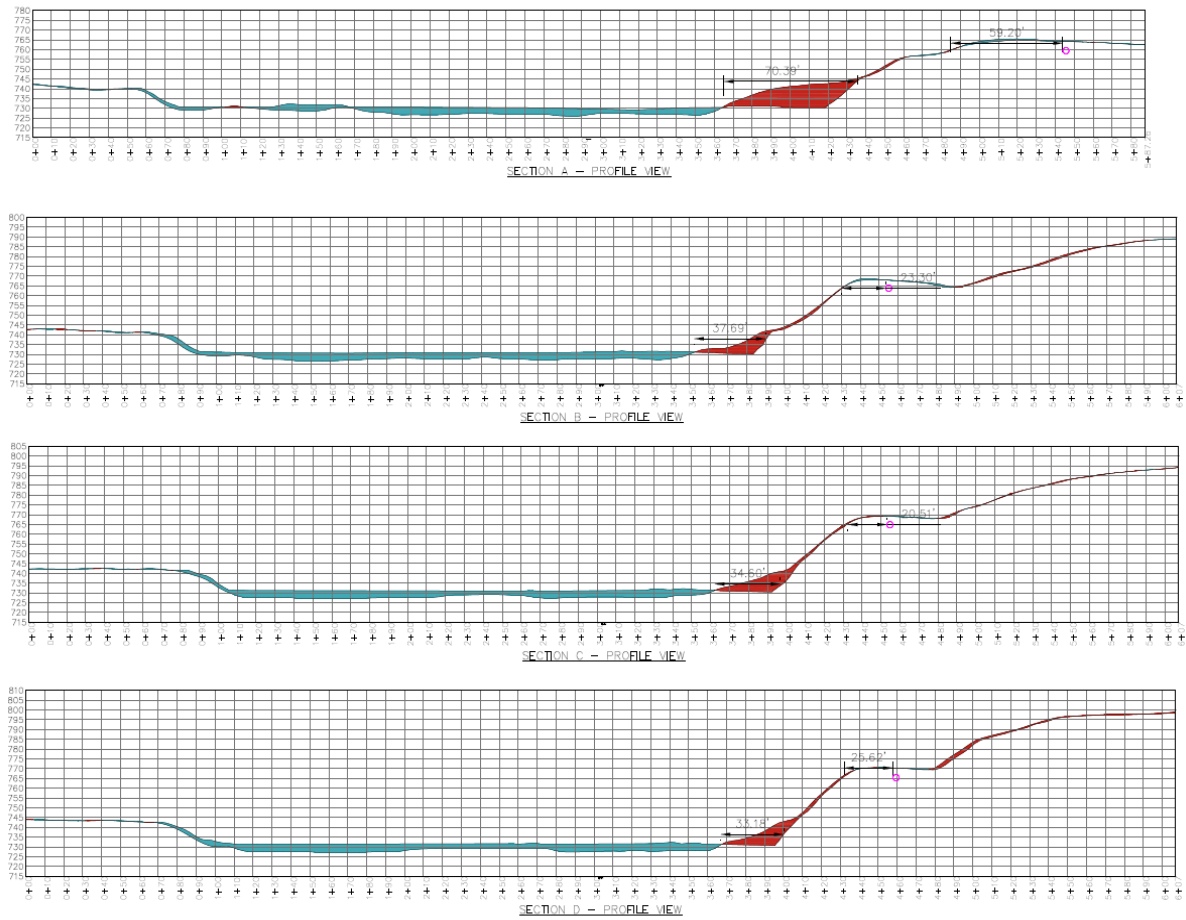
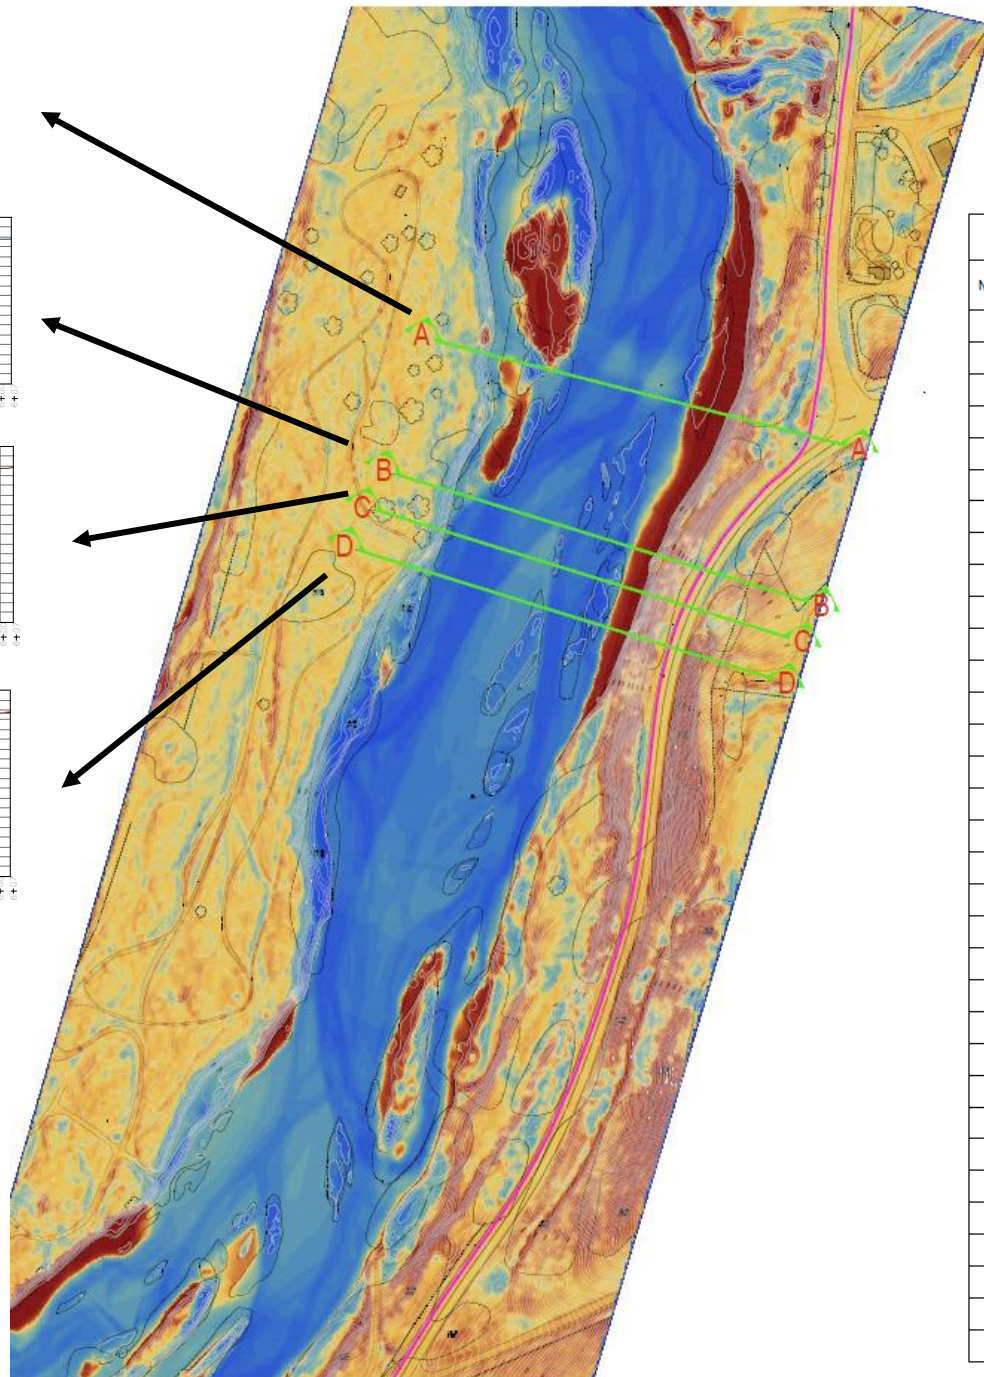
Stations 1306+00 and 1331+00

Final risk / consequence ratings were adjusted based on field investigations to achieve a final priority rating for each field site.

10 of the highest priority sites (highlighted in green) were put forward for detailed topographic surveying.
