# Sitlika Creek: the Bad, the Ugly and the Really Ugly

Brad Fairley, MES

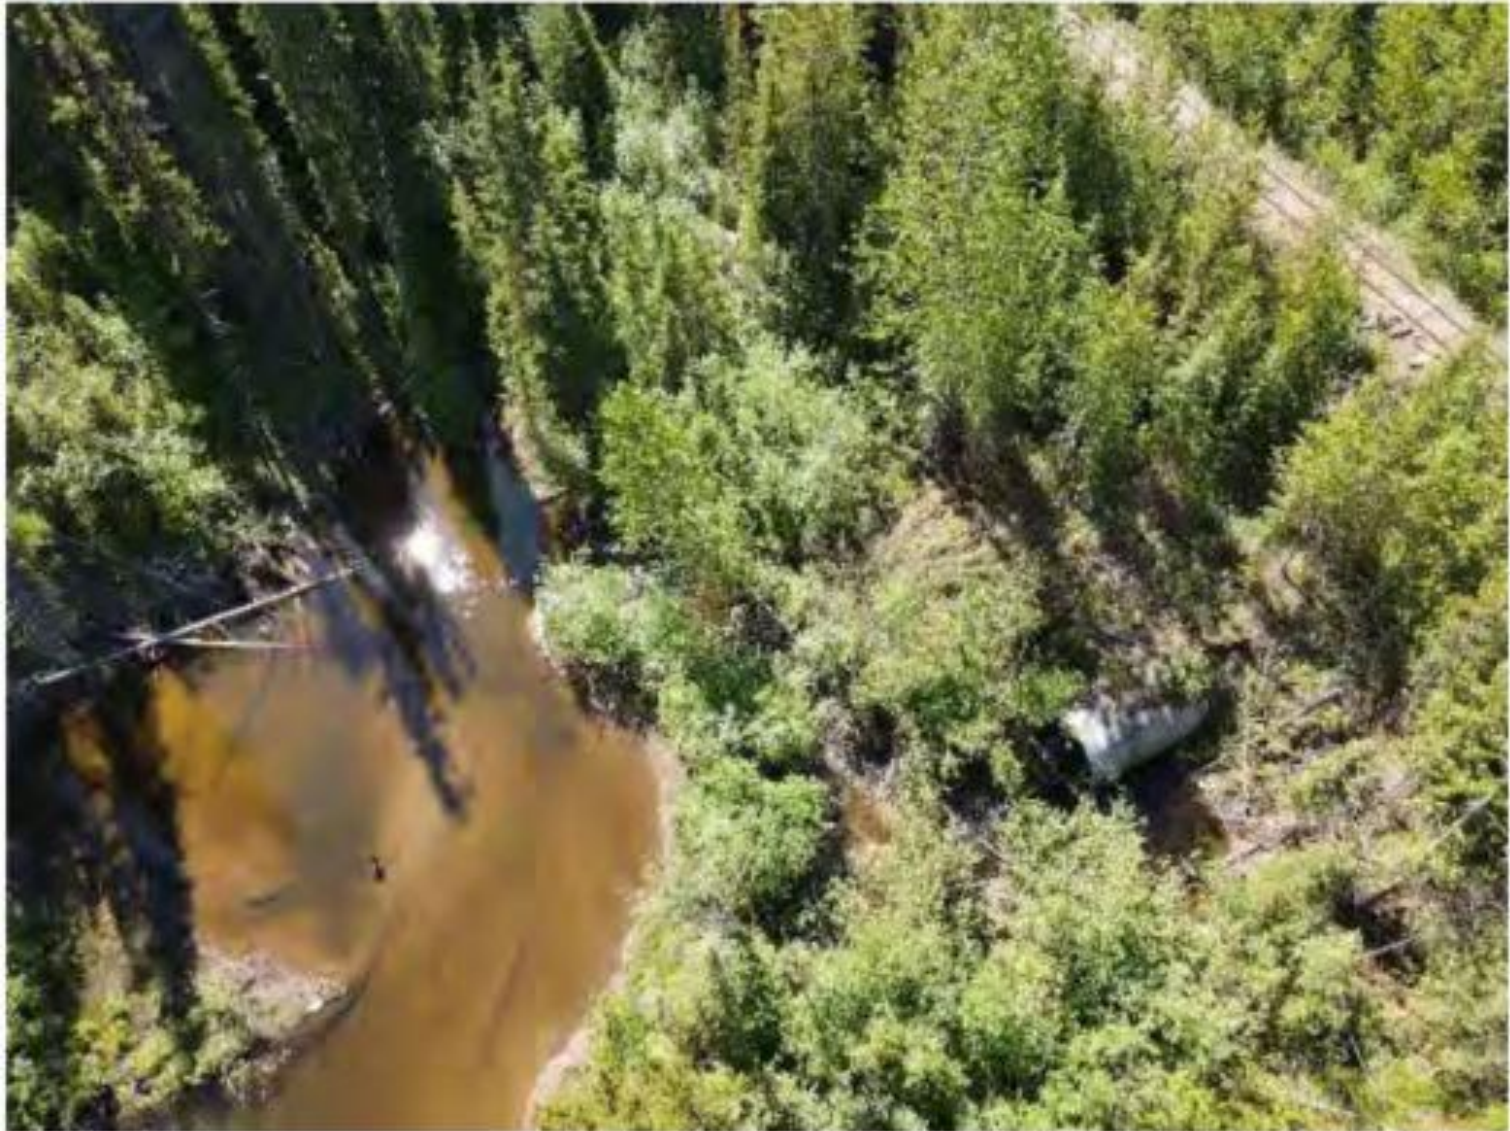
Figure 1-5: Aerial view of channel flowing into culvert inlet

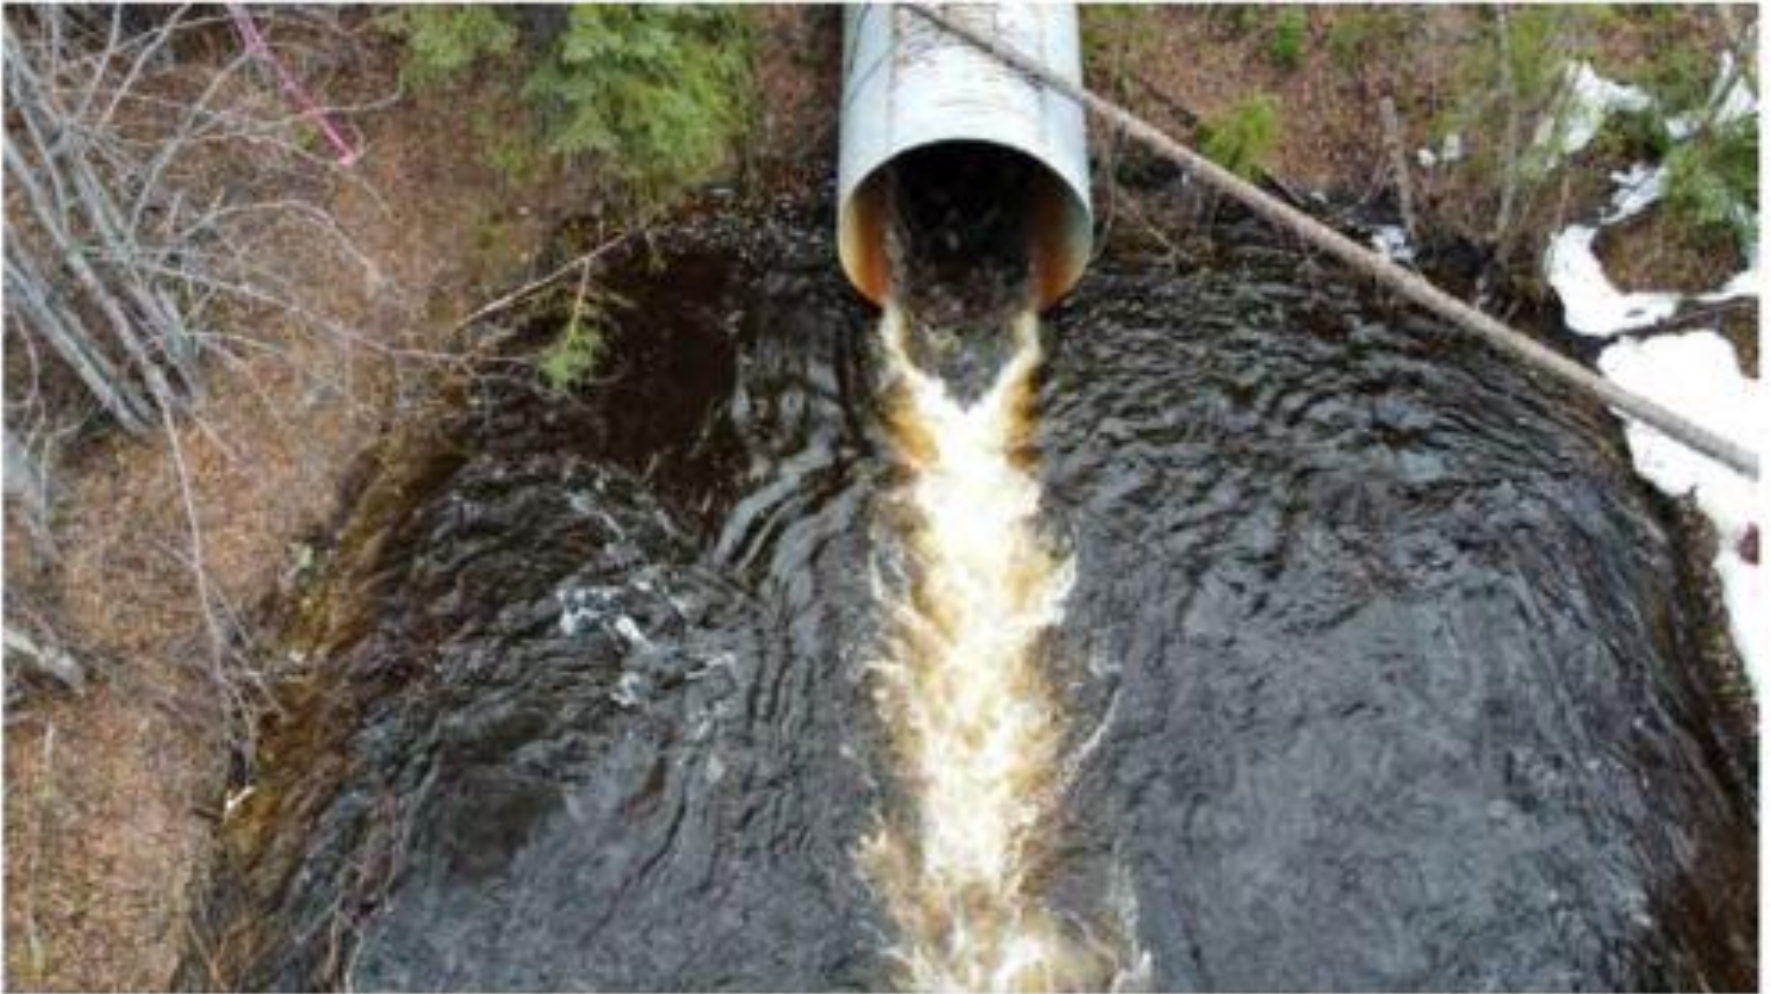
Mile 205.6. Sitlika Creek. May 24, 2021. Upstream view showing the railway culvert outlet.

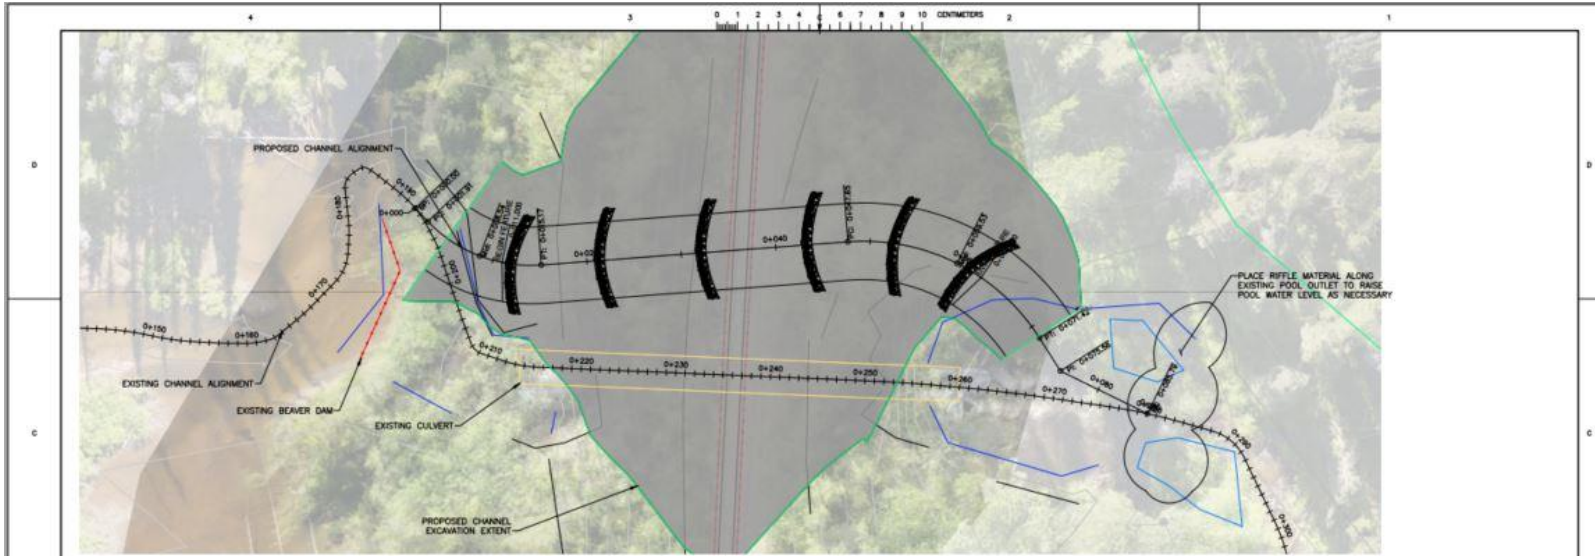
PLAN VIEW  
1:200

- RR asked 5SSR to do a post-mortem
- Issues
  - Dimension (trapezoidal channel with an ER of 1)
  - Pattern (pool spacing was 2X the existing stream)
  - Profile (too steep)
  - Structures (too small, not keyed into the bed or banks, did not centre the flow)
  - Erosion control measures were inadequate

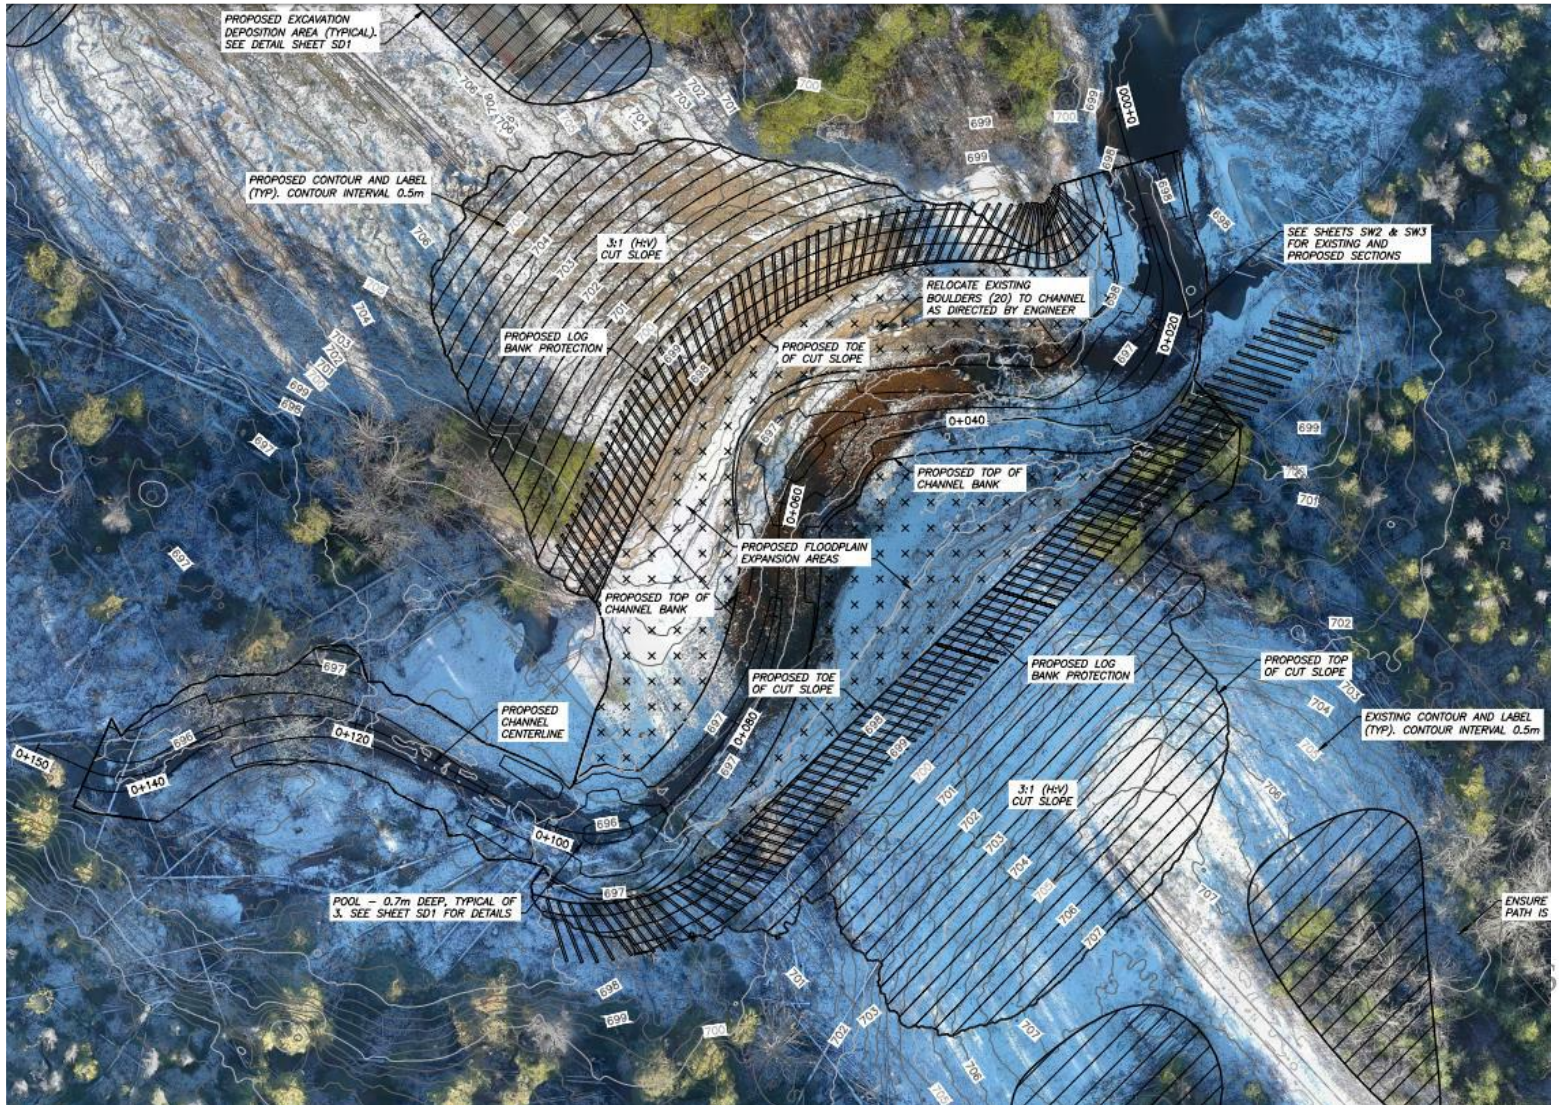
- RR asked 5SSR to coach the designer
- Improvements
  - Added a floodplain
  - Flattened the slope on the cut through the embankment
- Issues
  - No change in slope / no grade control
  - Channel is too large
  - Nothing to hold TOB
  - Scour on the floodplain
- Conclusion: It would fail if constructed
