Bridges (and more) Over Troubled Water:

Region-Scale Erosion Hazard Screening to Support Municipal Asset Management

8th Conference on Natural Channel Systems | June 8-10, 2026

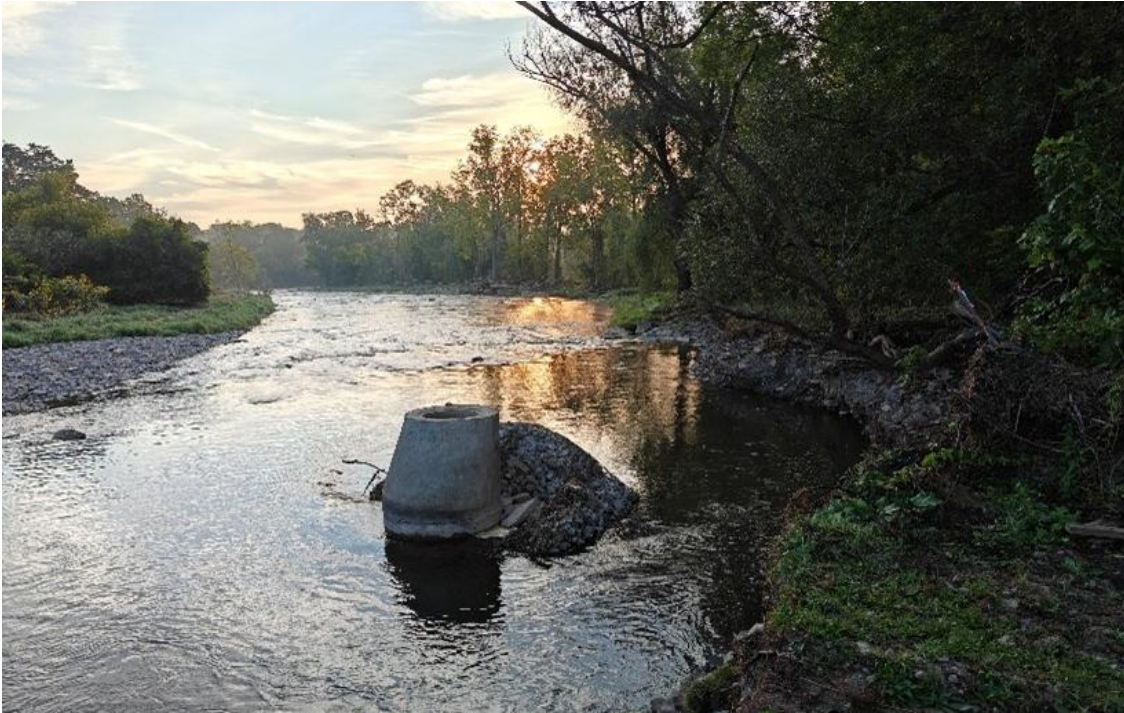
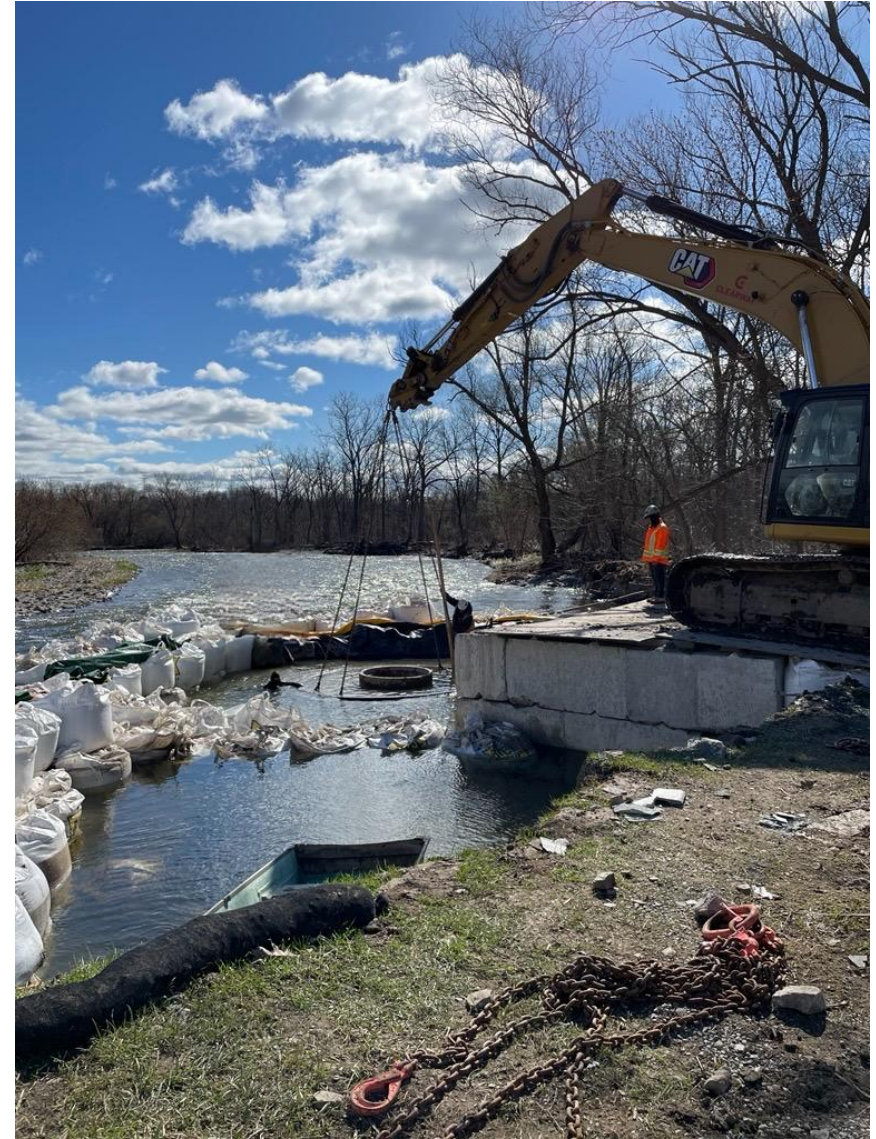
Exposed MH

- Assessment identified MH high risk of erosion
- Shortly after high flow event caused erosion
- Emergency works required to protect infrastructure and environmental
