# Protection of Municipal Sewer and Water Assets Around Urban Watercourses

Robert Chan – Toronto Water, City of Toronto

Rob Amos – Aquafor Beech Ltd.

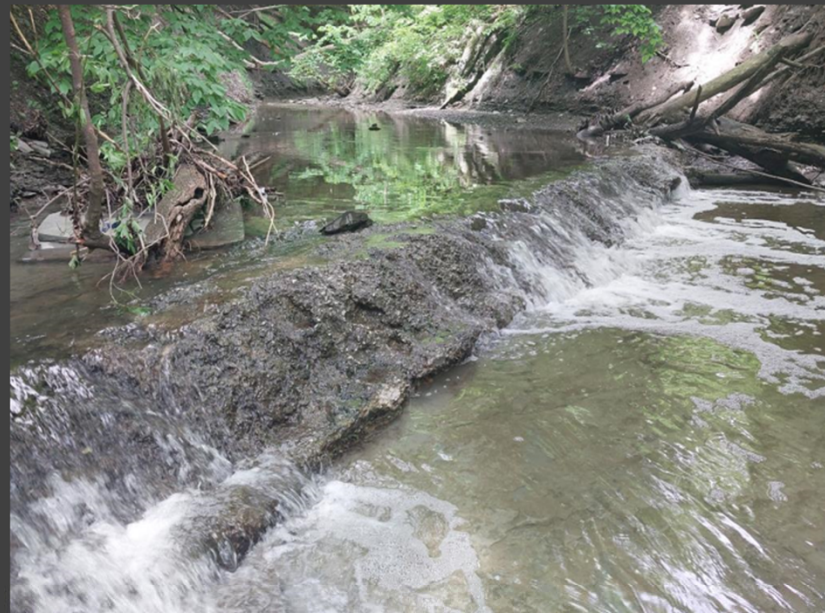
SL2204411

1.1

Poor

- Moderate to major surface spalling
- PACP Structural Rating = 3  
-wrinkled lining feature

9

Very High

- % exposure= 53% (below spring line)
- No erosion control on both banks and midchannel

- Trunk Sewer: Very High Impact
- Entire crossing is exposed
- Diameter < 900 mm

89

Trunk Sewer  
Humber Creek– Lower Humber River  
La Rush Drive

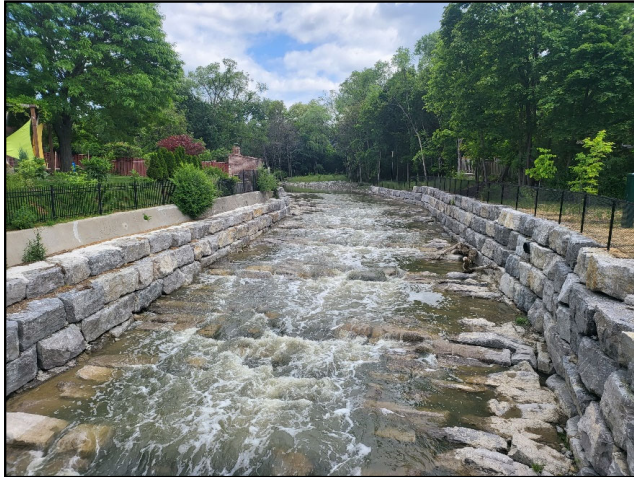
Condition: Good

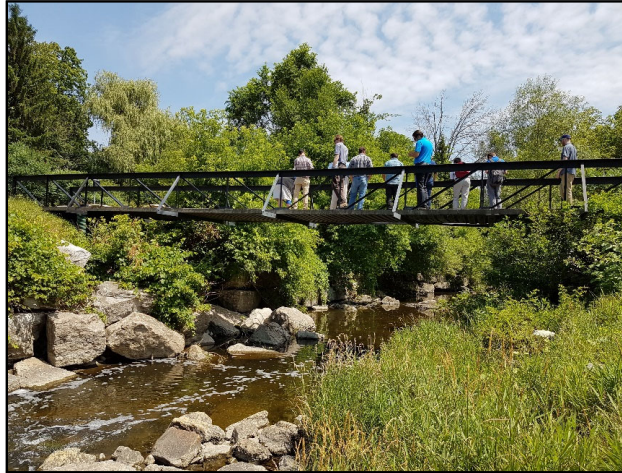
Condition: Needs Repair

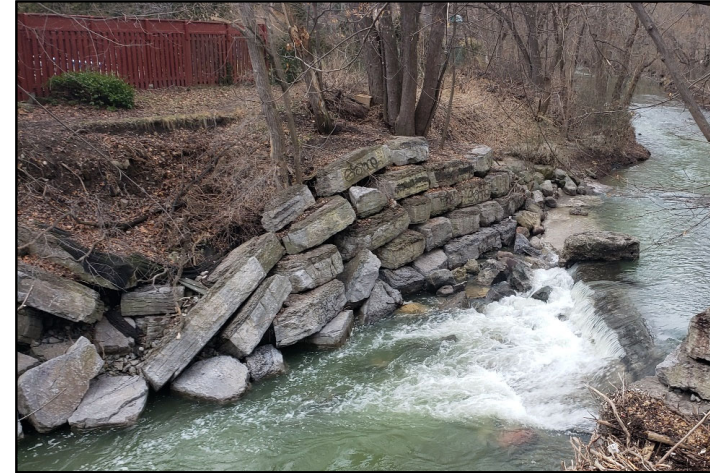
Condition: Failed

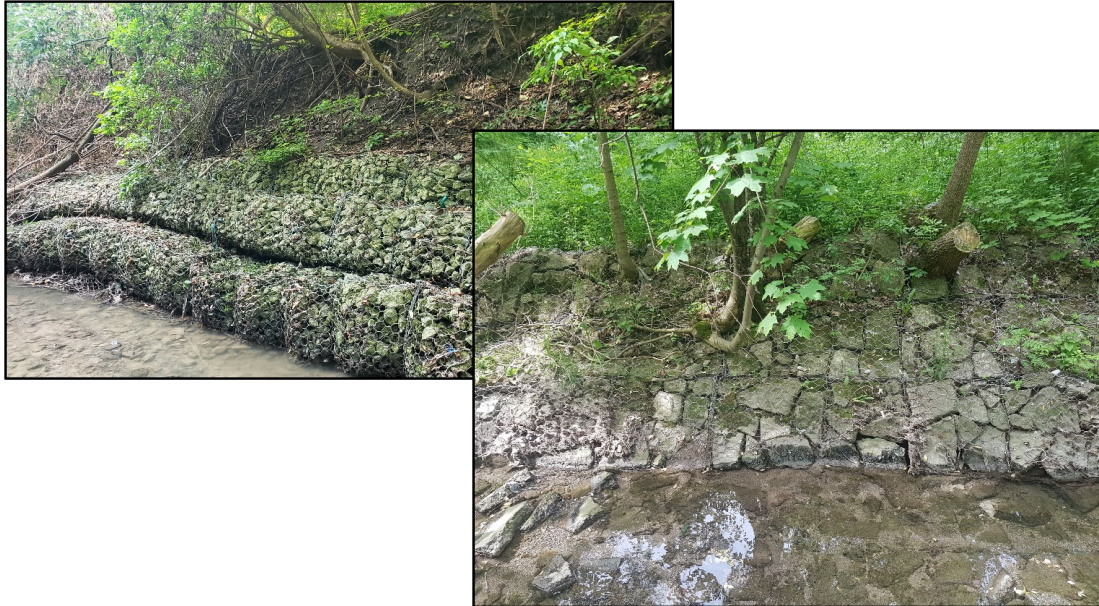
Condition: Acceptable

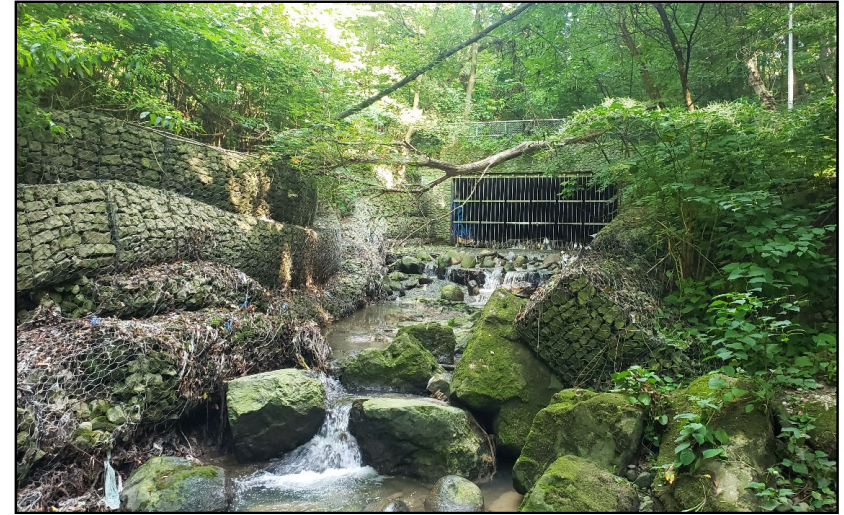
Condition: Needs Repair
