Sheppard-Leslie DWST-2 and The Don River Lessons Learned

Don McBrayne, P.Eng.

Natural Channels Conference 2026

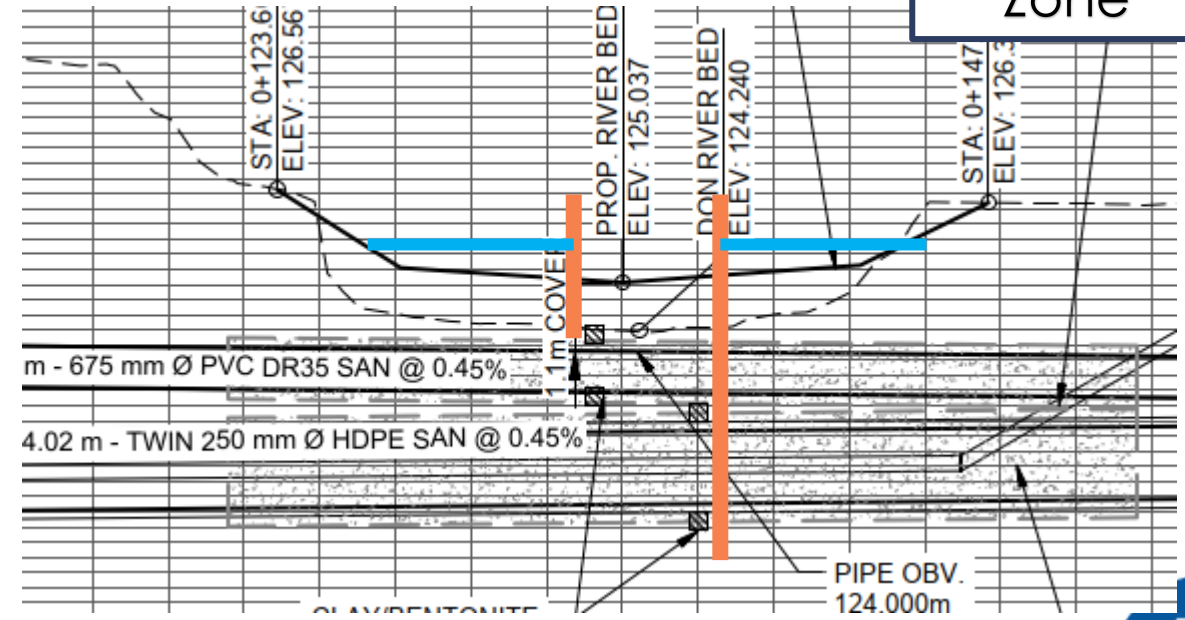
Construction Challenges

- Transition Zone
- Complexity
- Cofferdam Height Limitations

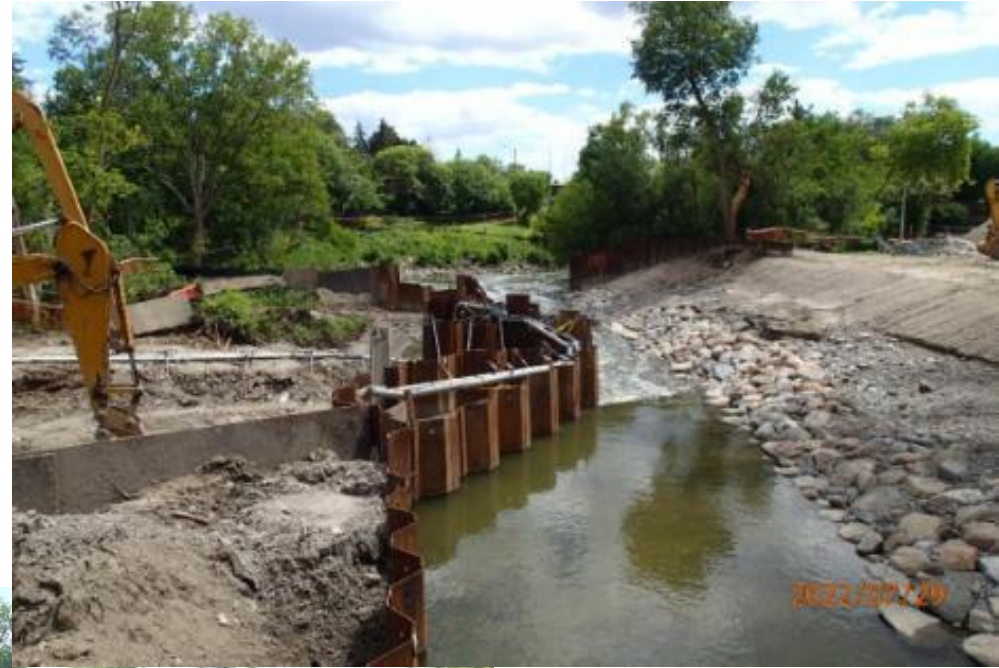
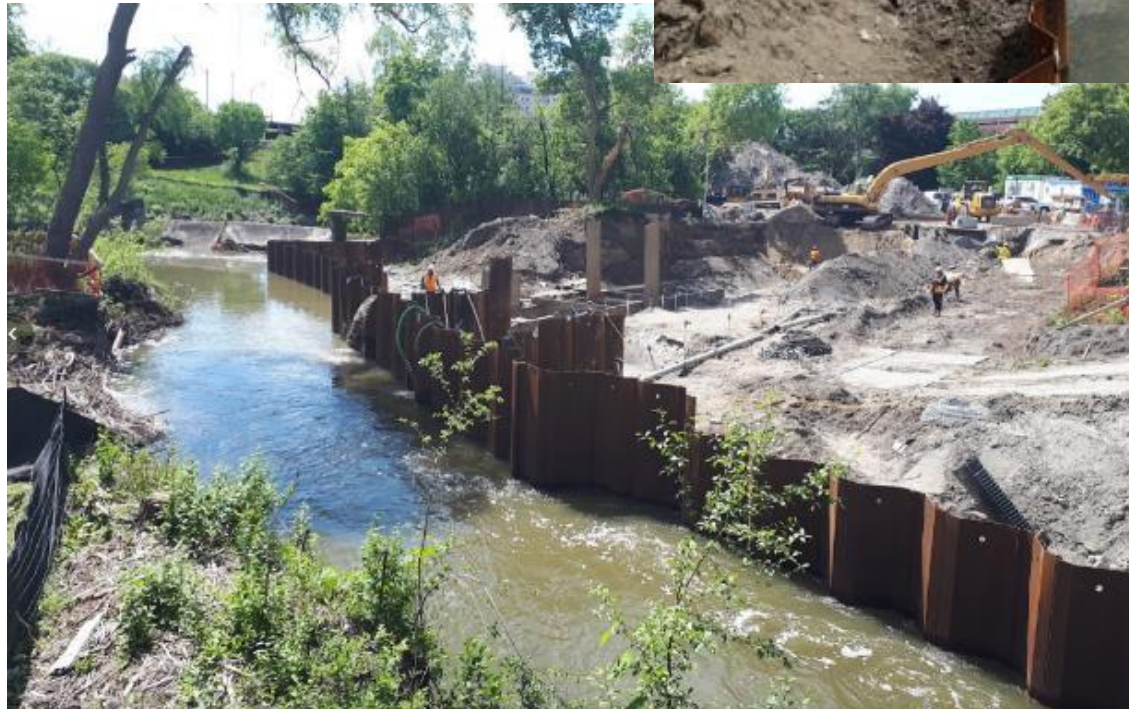
Construction Challenges

- Transition Zone Complexity
- Cofferdam Height Limitations
- Narrow bypass

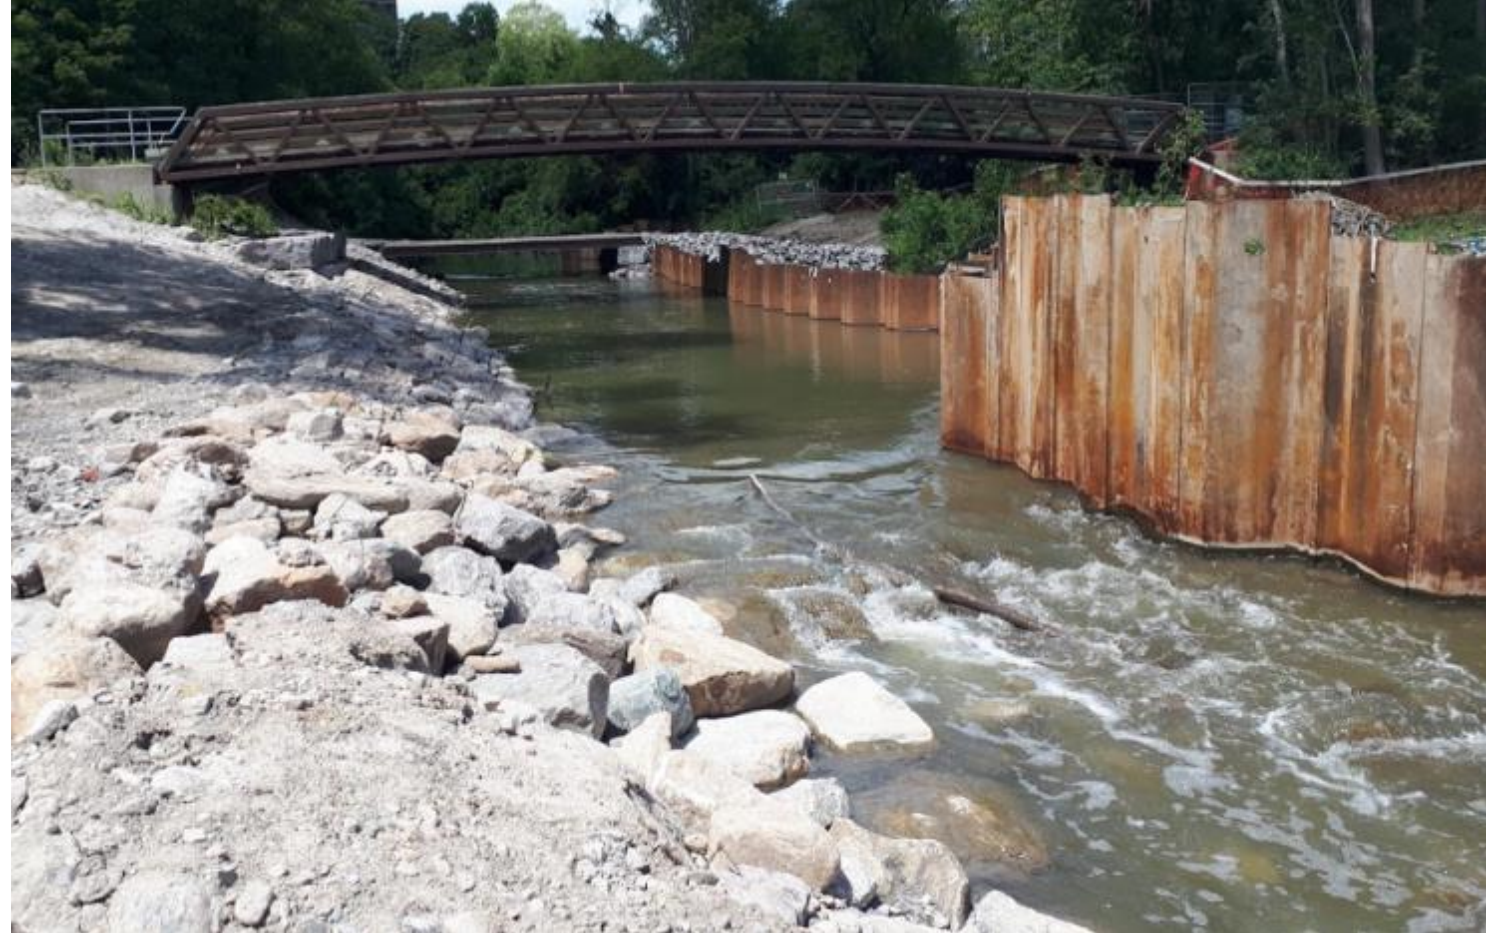
Issues During Construction

- Frequent Overtopping
- Rapid Response Storms
- Unpredictable Peaks
- Scour at narrowed Transition
- Soil washing off VBR

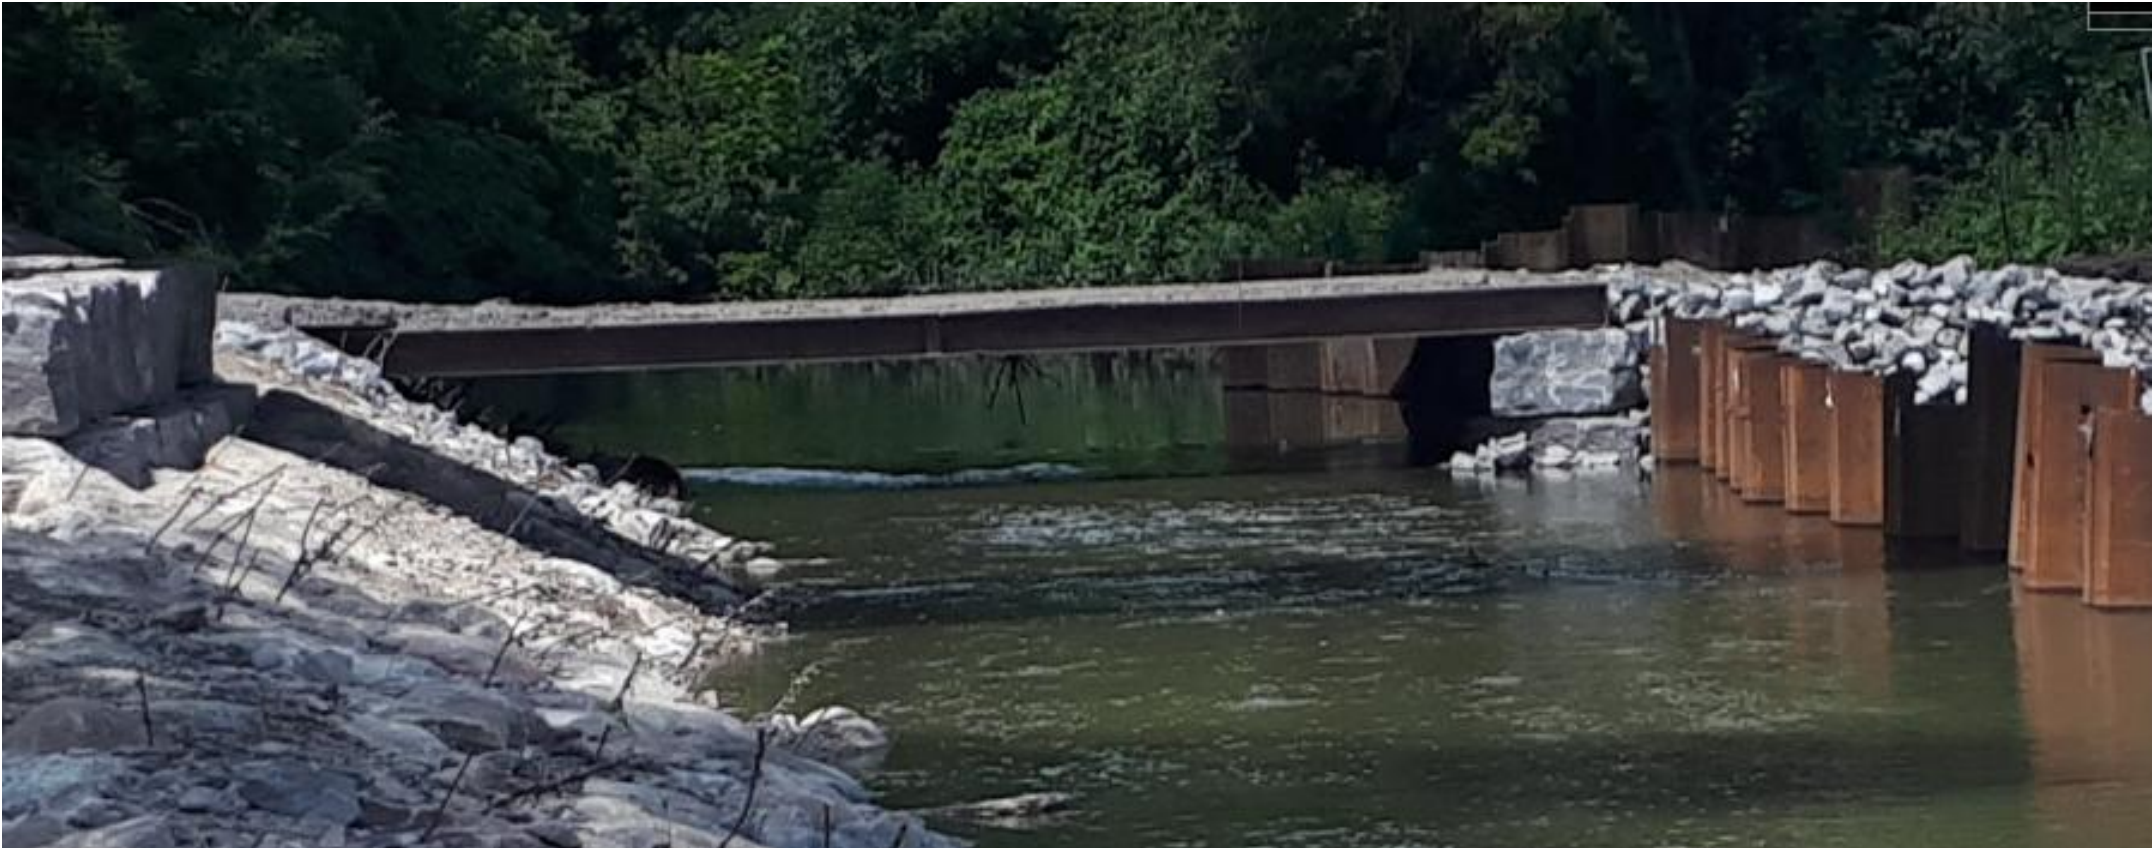
Issues During Construction

- Contractor Bridge Obstruction

- Temporary Access – If Contractor knowingly impedes bypass flow, request written understanding of impacts.

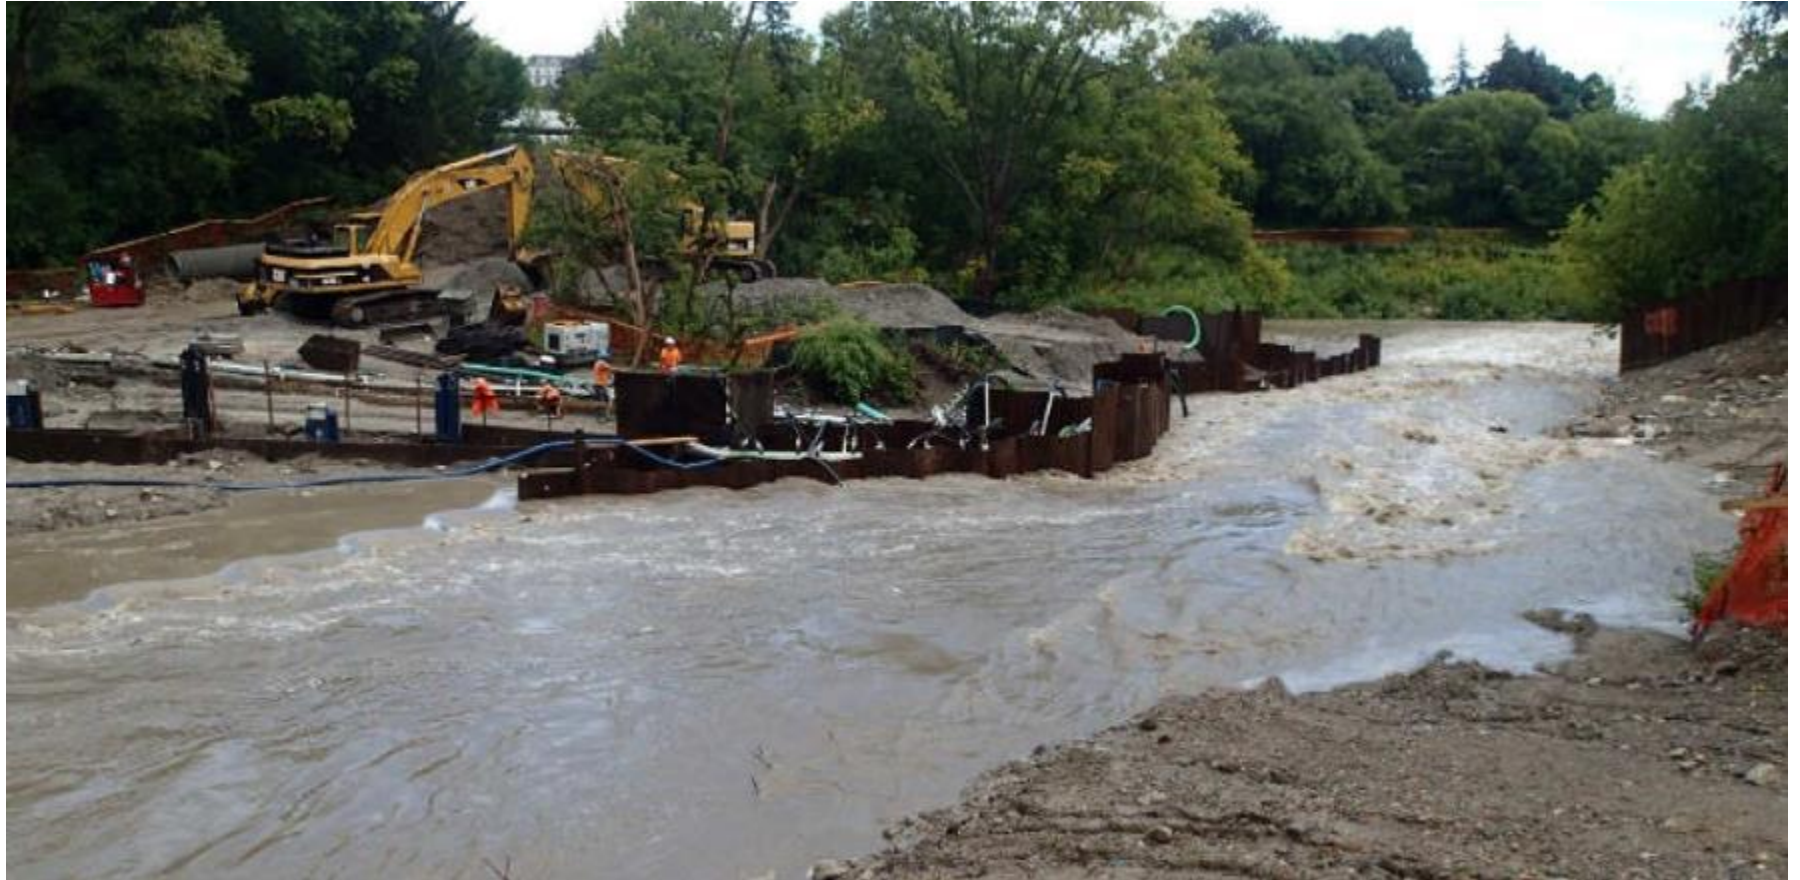
Issues During Construction

- Flows overtopping coffer dam sheet piles
- Washout finished VBR bank

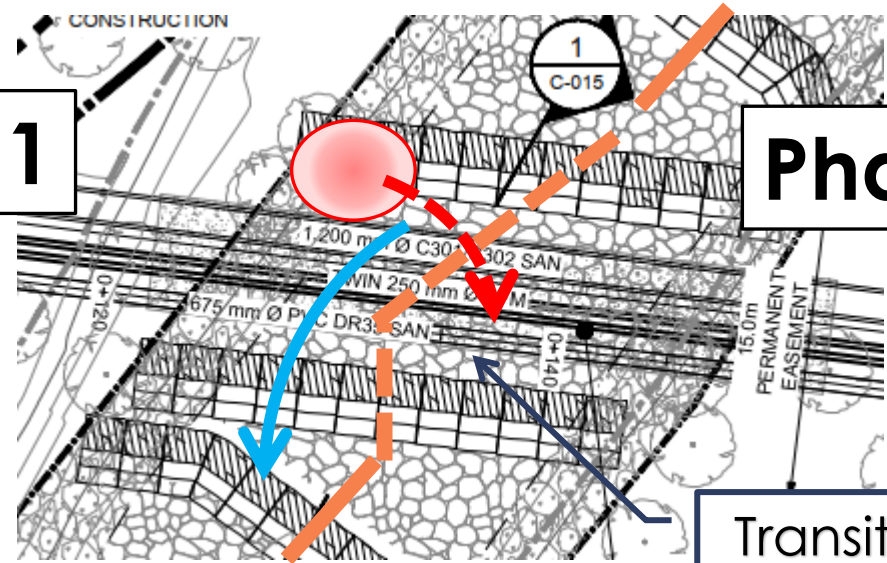
- Sink Hole Undermine

- Sink Hole Undermine
-?
- Clay backfill?
- More stone backfill? No Granular?

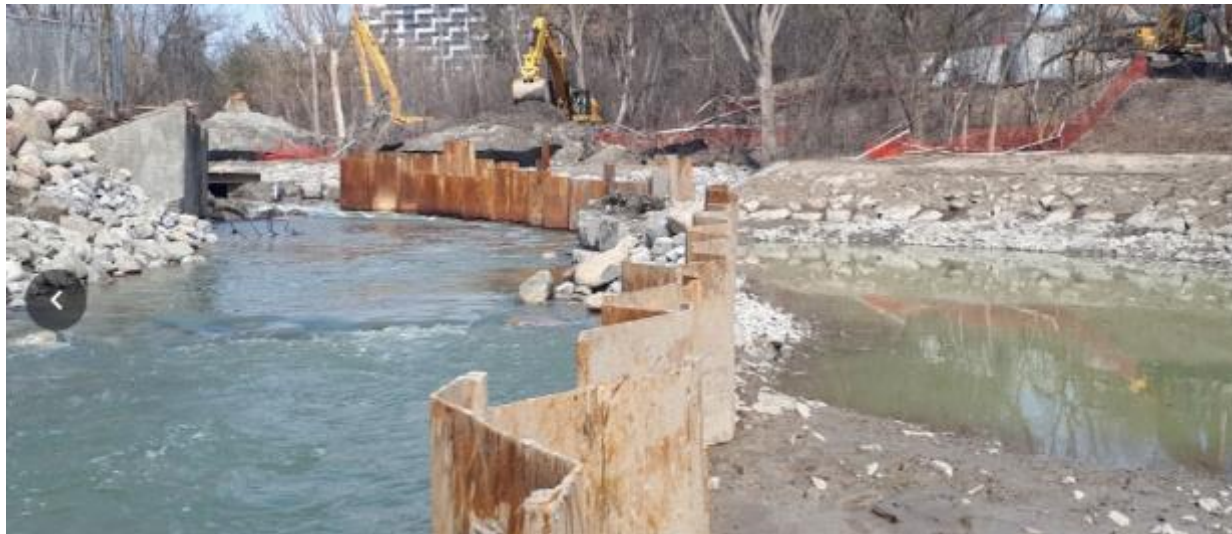
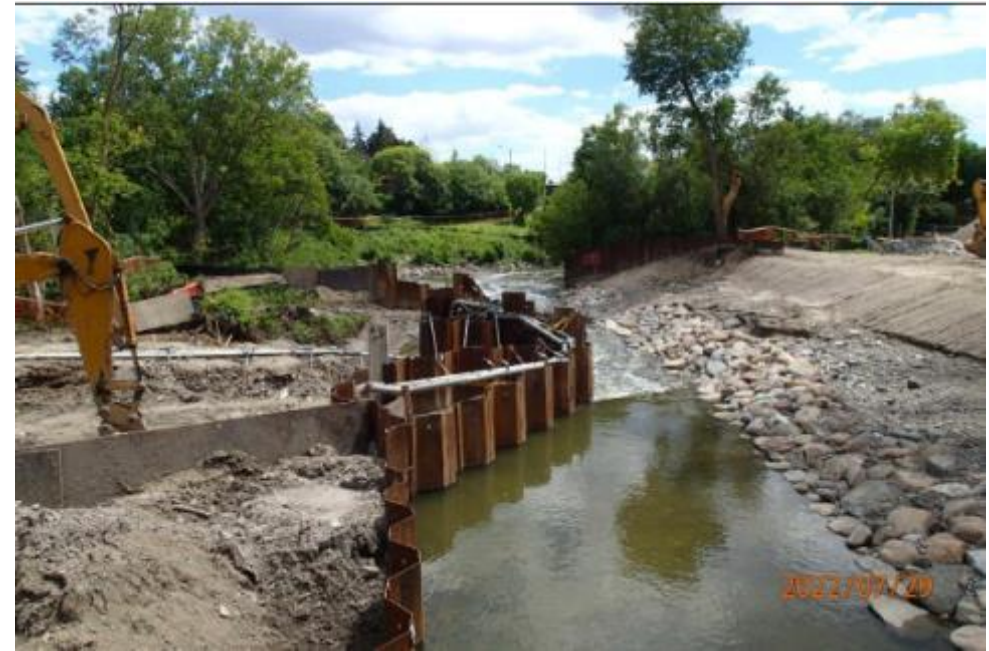
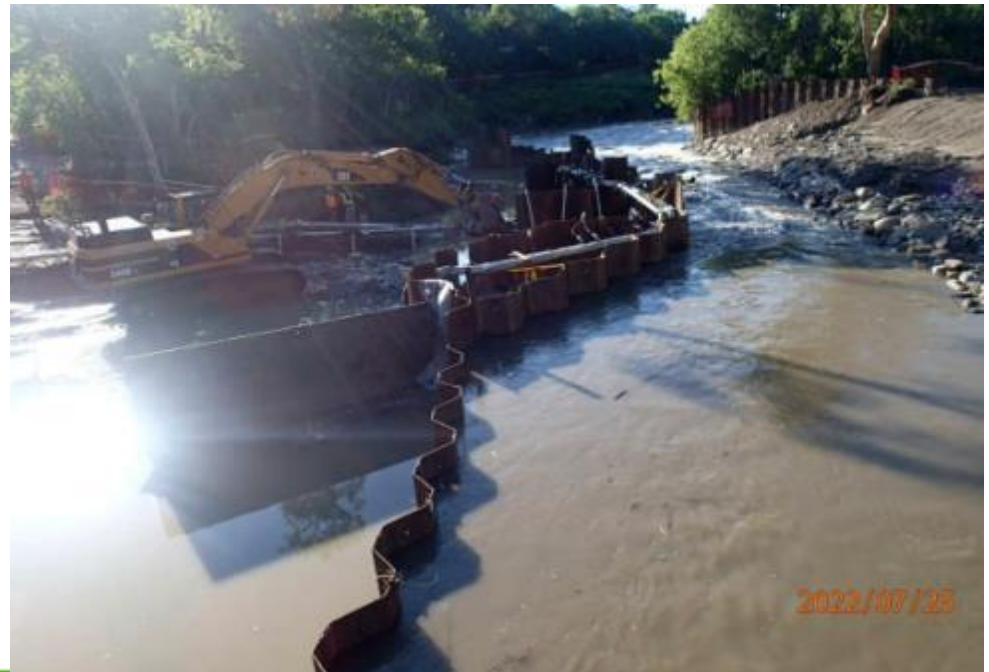
Lessons

- Higher Min Height of Cofferd Dam
- Disregard surrounding elevations

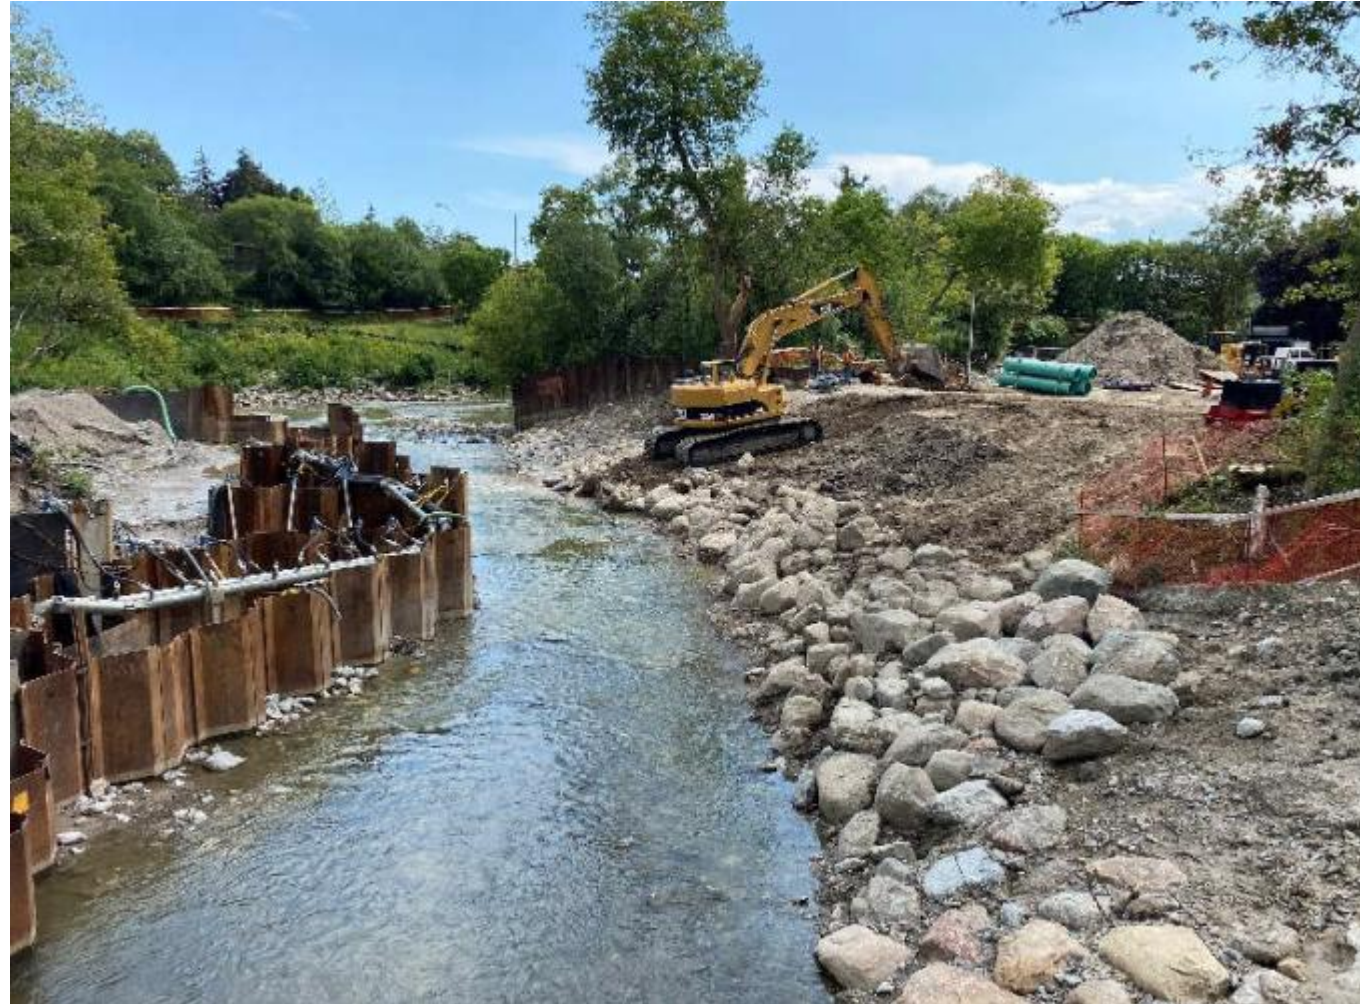
Lessons

- Flow Diversion – maintain existing flow width.
- Scope for Interim Conditions Modelling and Design

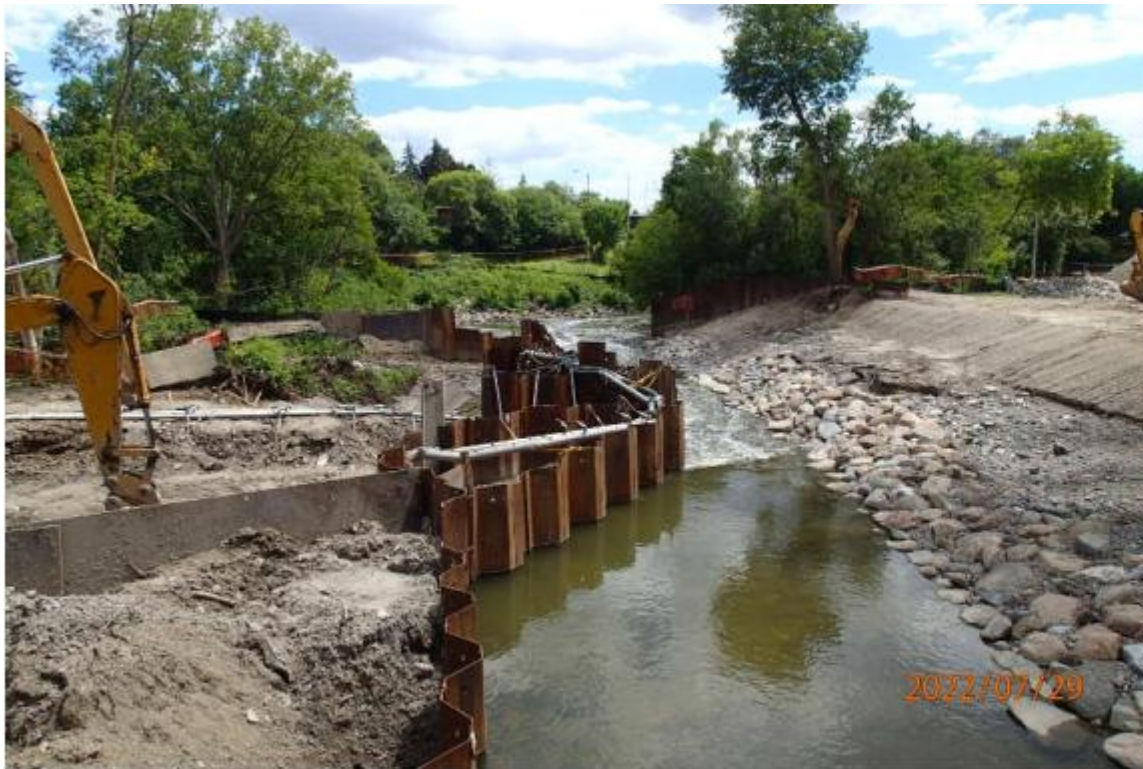
Picture 27: Site conditions, south of bridge.

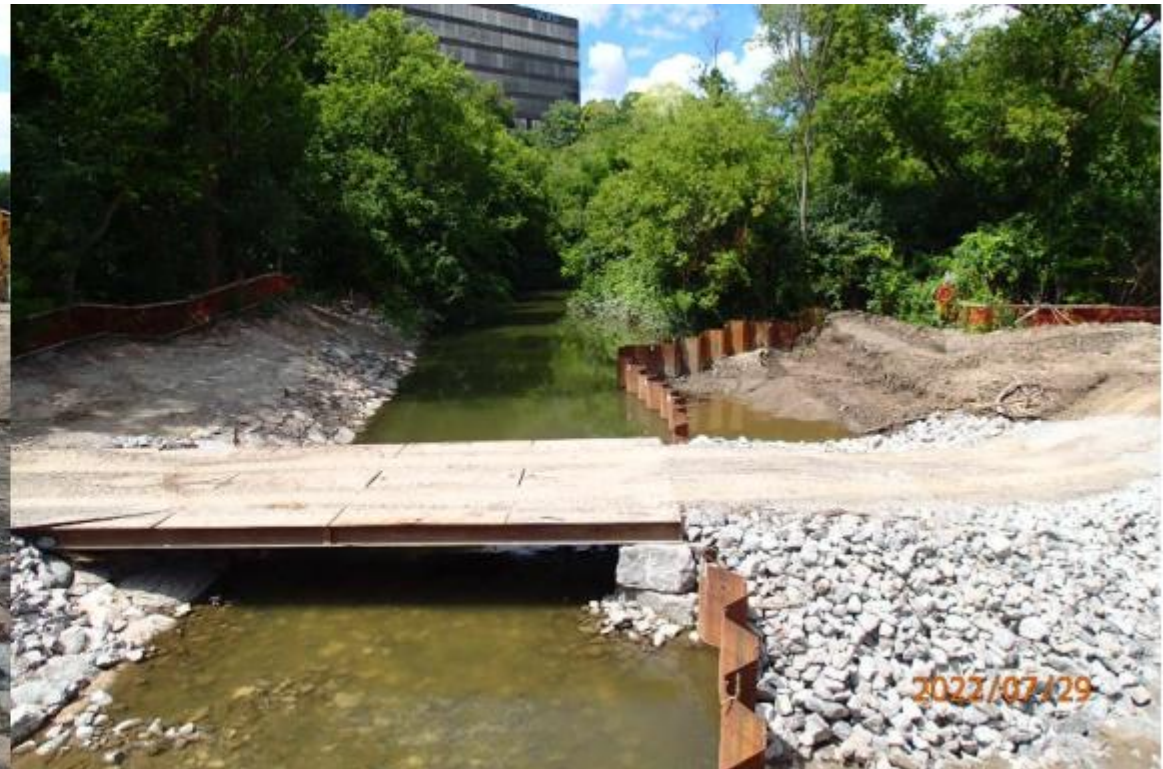
Picture 28: Site conditions, north of pedestrian bridge.

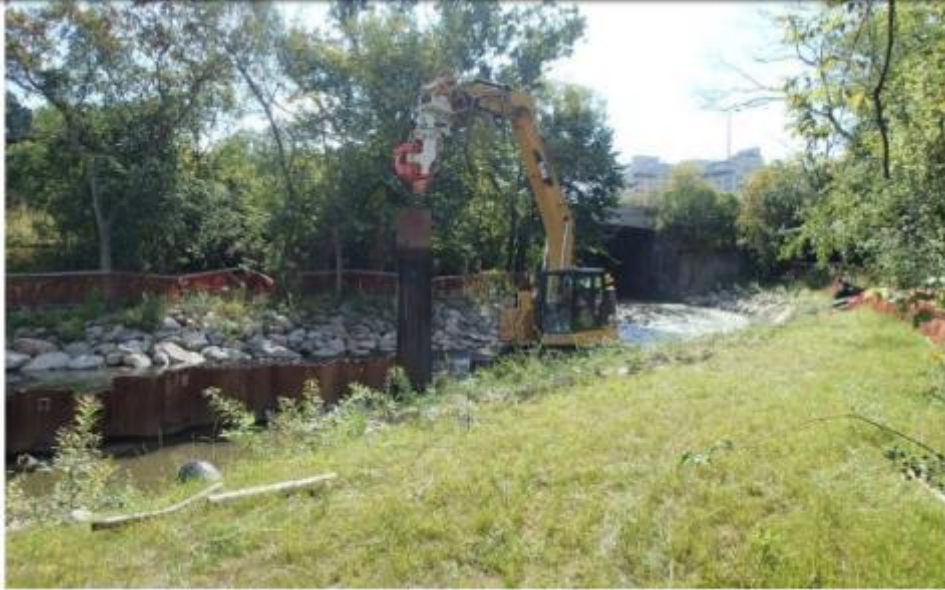
Picture 13: Cofferdam sheet pile removal.

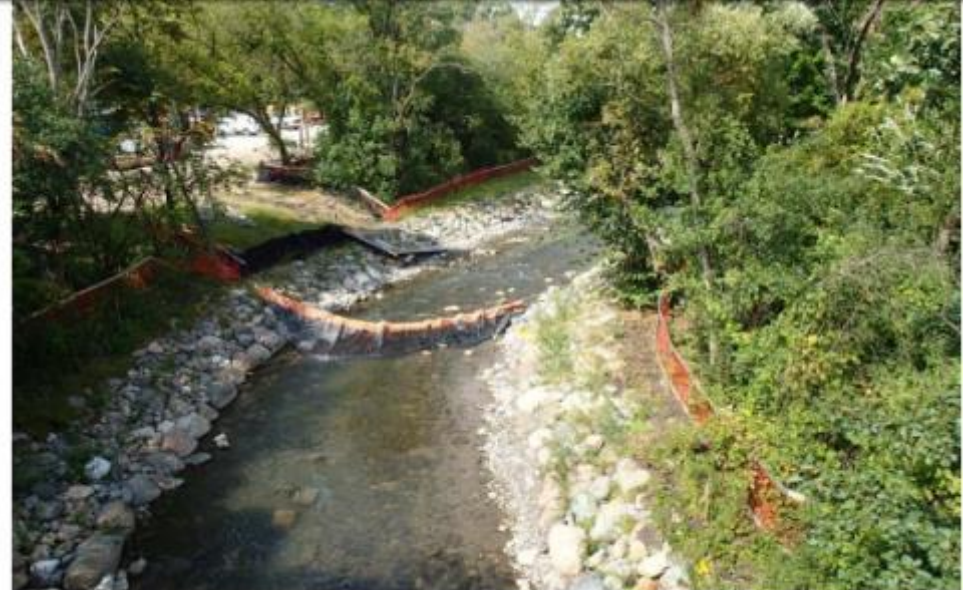
Picture 14: Cofferdam, silt curtain placement.
