Management of Toronto's Watercourses over nearly three Decades

(Reactive, Proactive & Adaptive Management)

Natural Channels Conference *June 8-10, 2026*

Session G Management of Natural Channel Assets and Urban Infrastructure

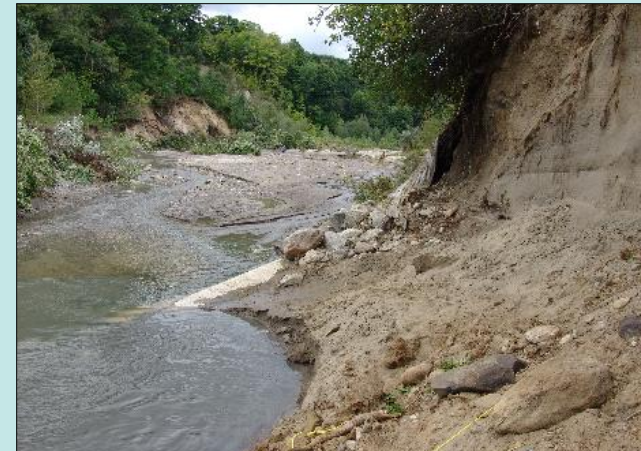
Break At Meander Cutoff
AUGUST 2005 (POST-STORM) Ortho Images

An aerial photograph of a river valley. A pink line is drawn across the image, following a path that appears to be a sewer line. The line starts from the left edge, moves diagonally down and right, then turns more sharply down and right, and finally turns slightly up and right. A white arrow points from the text 'Trunk Sanitary Sewer' to the pink line. The river is visible in the center and right, with a meander cutoff. The surrounding terrain is hilly and covered with sparse vegetation.

“An Act of God” - Meander cutoff occurred, MH and STS sections were lost

“Time of photo – about one week later – Aug 26-27

- Creek redirected and trench excavated to intercept the sanitary flows
- Spill contained by Monday evening (Aug 12)
- Permanent repair of the trunk sewer completed fall 2005 (Emergency Tender)
- Design (and EA in parallel) for most appropriate method of protection from further damage for this valley segment initiated in Sept 2005

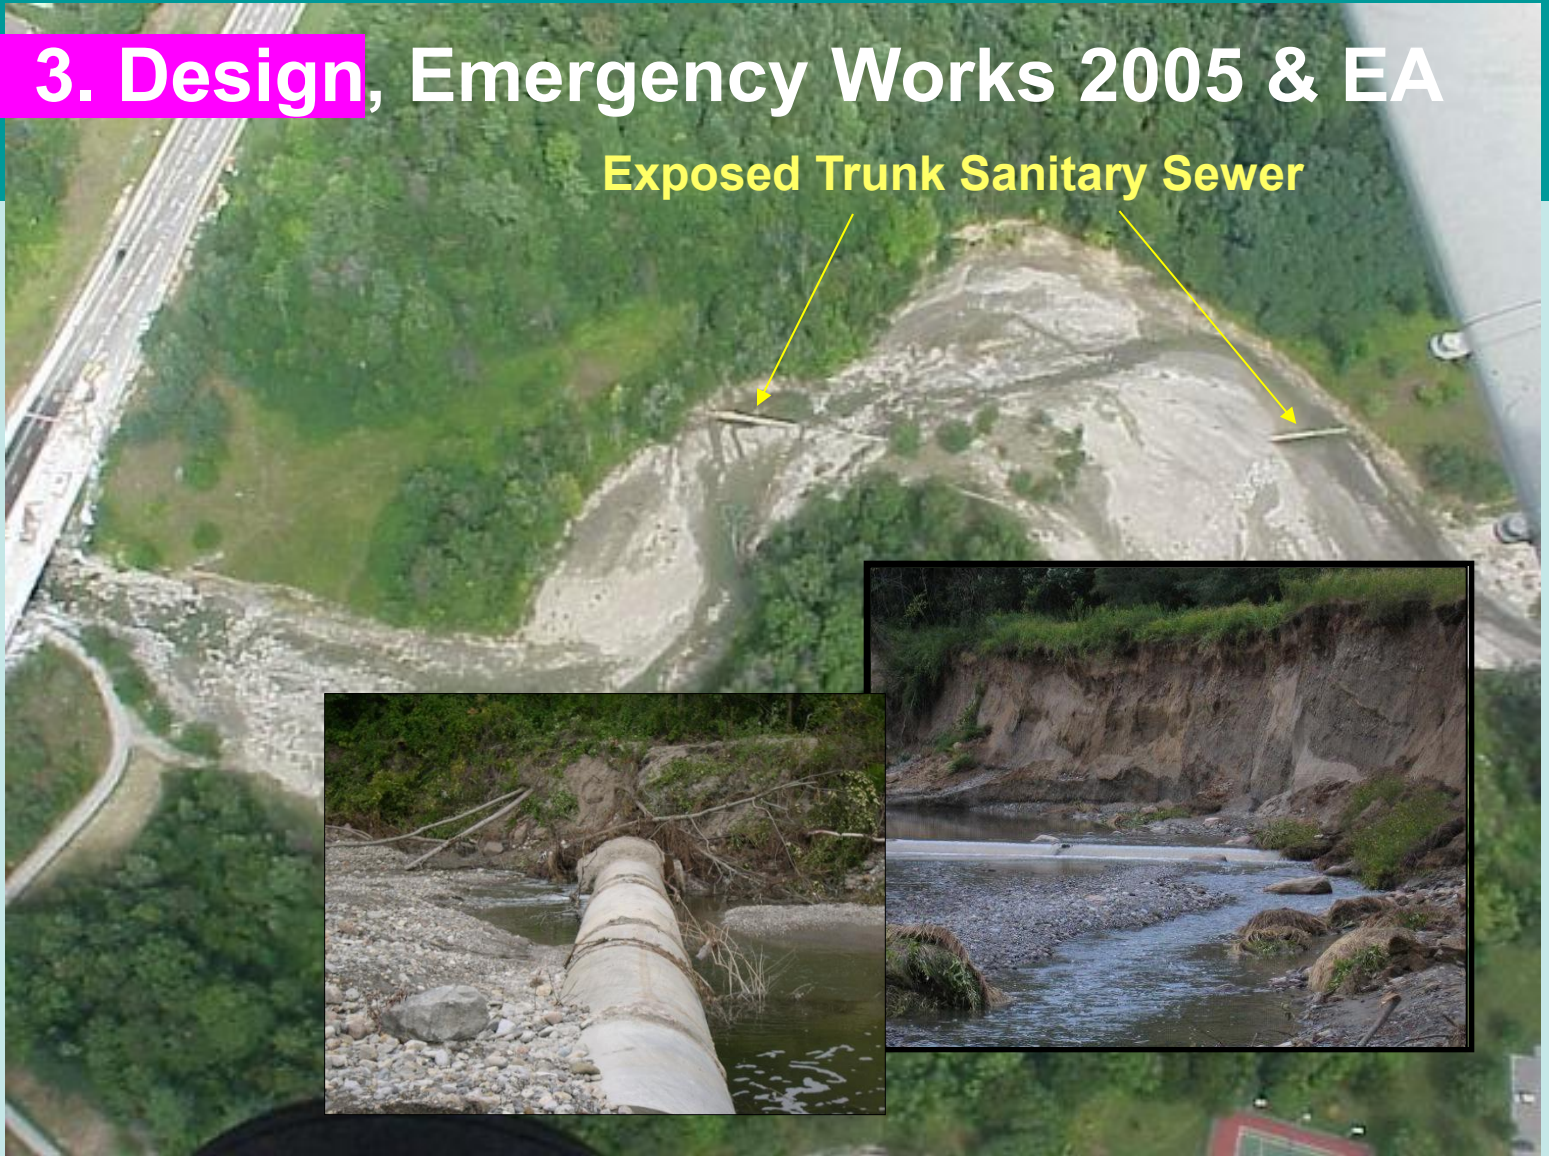
Exposed Trunk Sanitary Sewer

3 Design - Place Creek where Mother Nature left it after Aug 19 2005

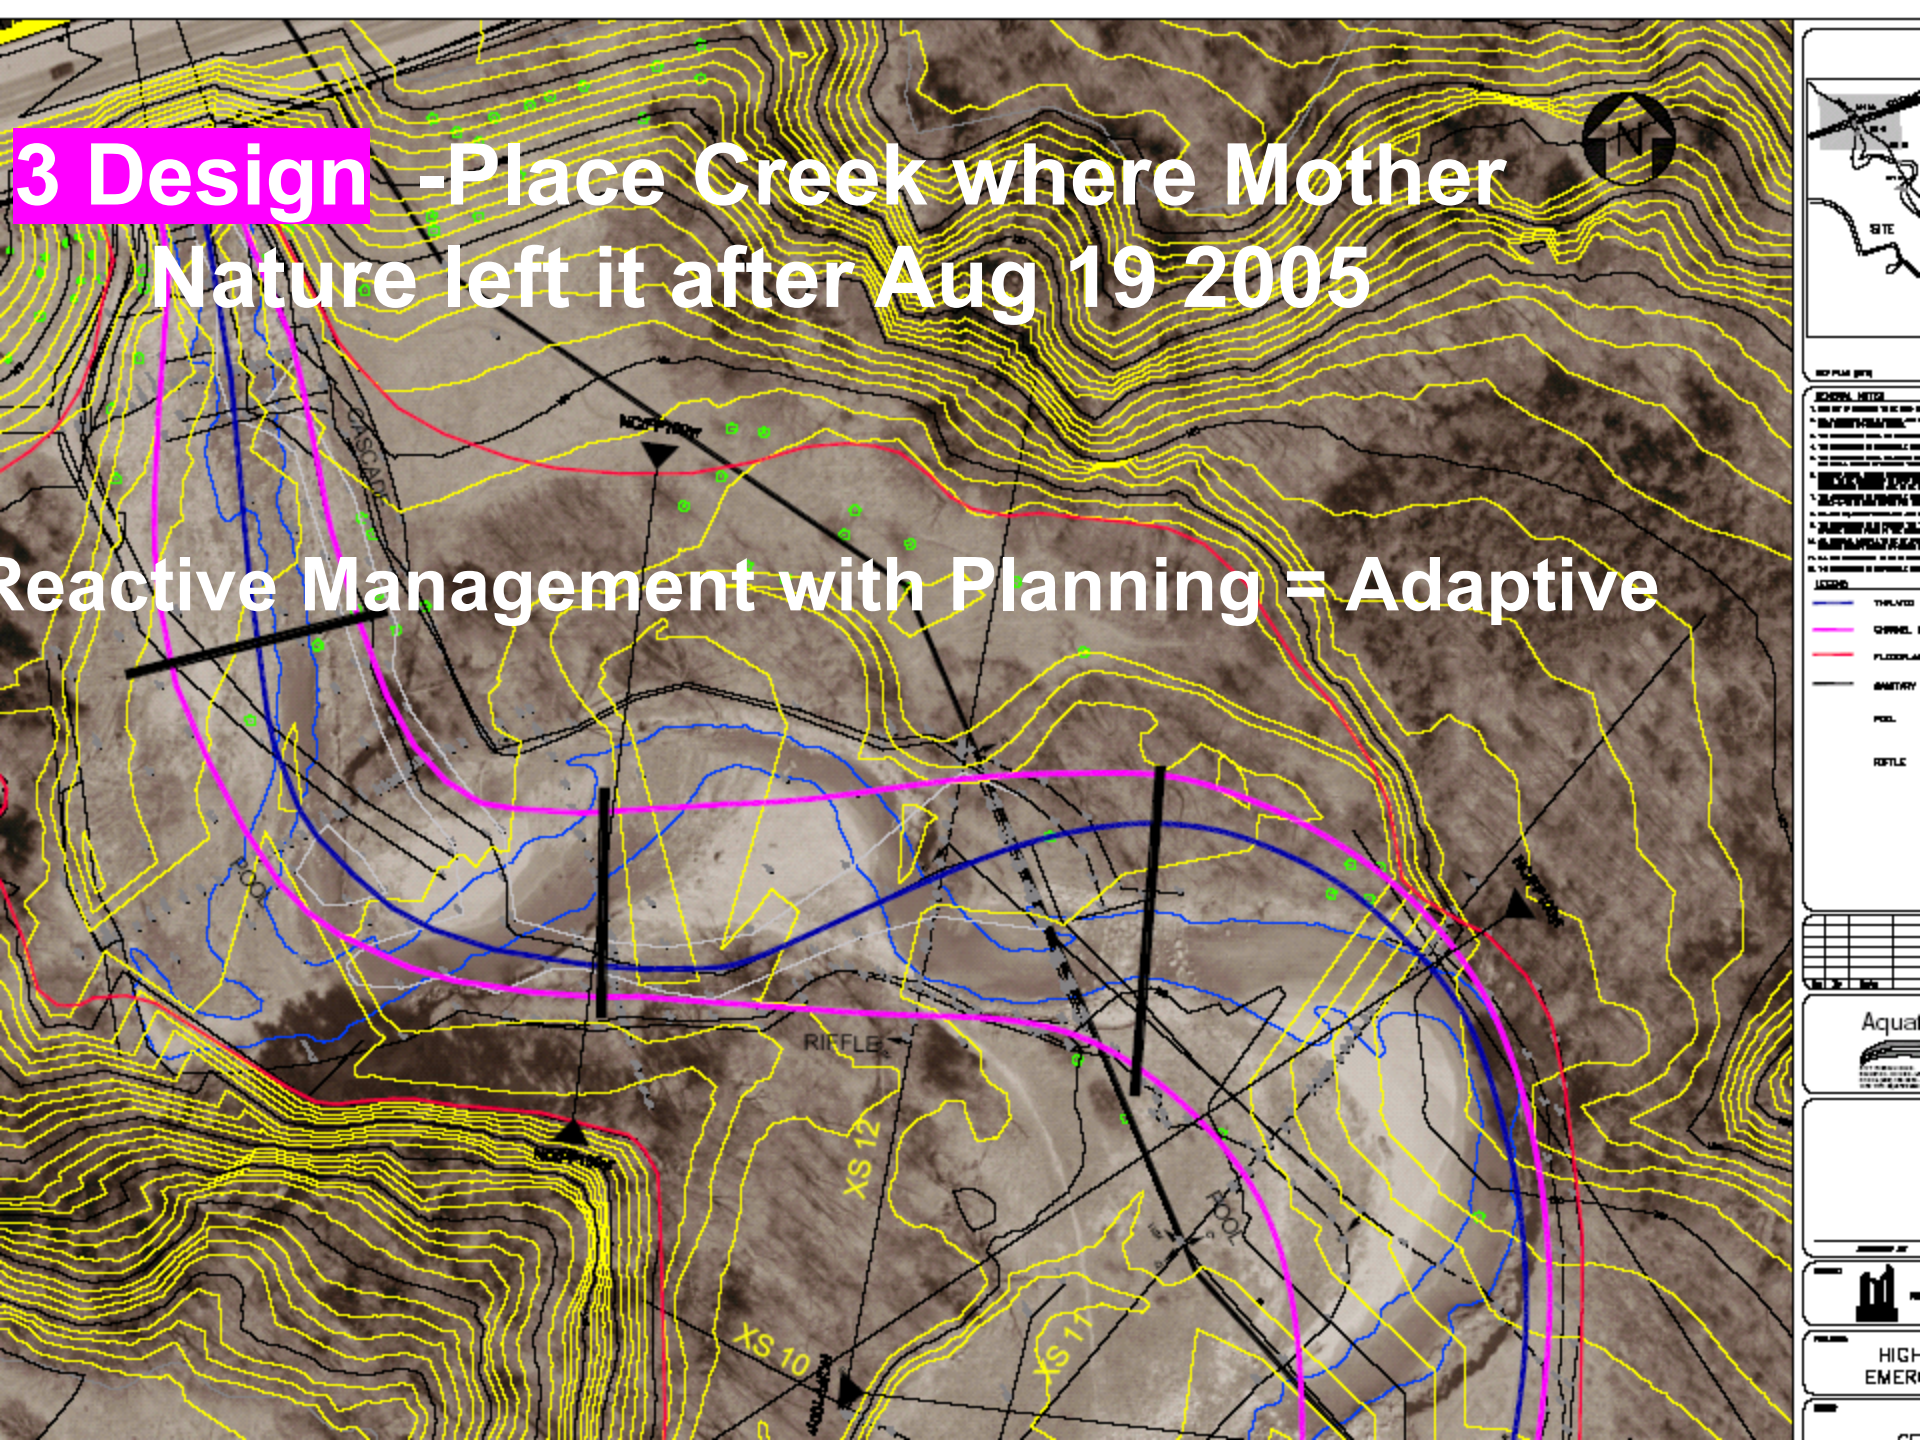
NOI PLAN SHEET

Reactive Management with Planning = Adaptive

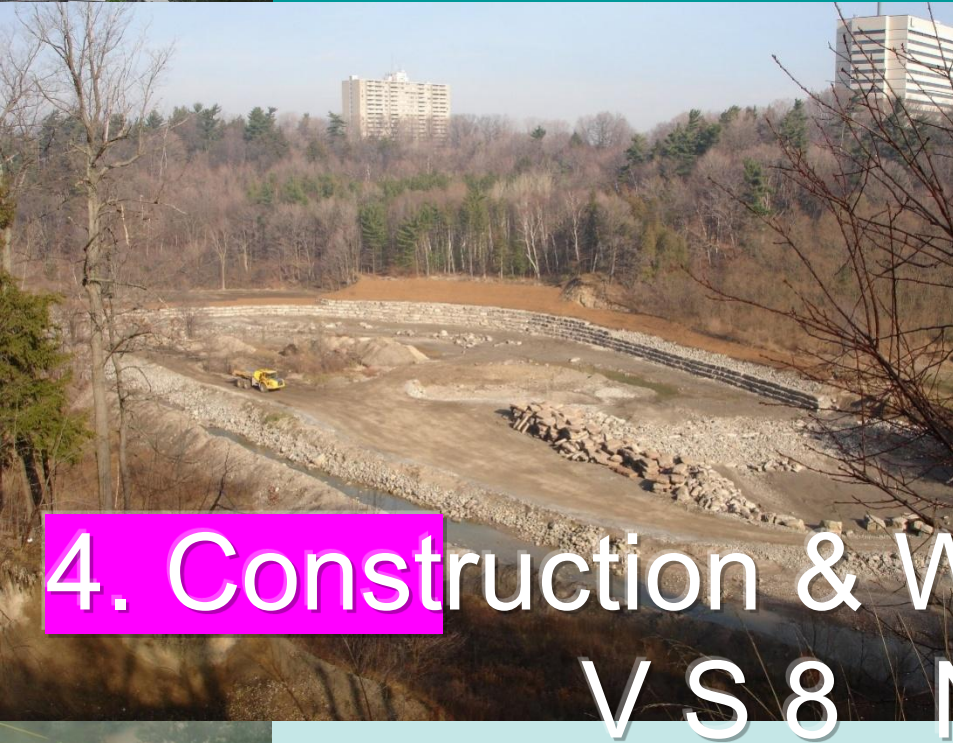
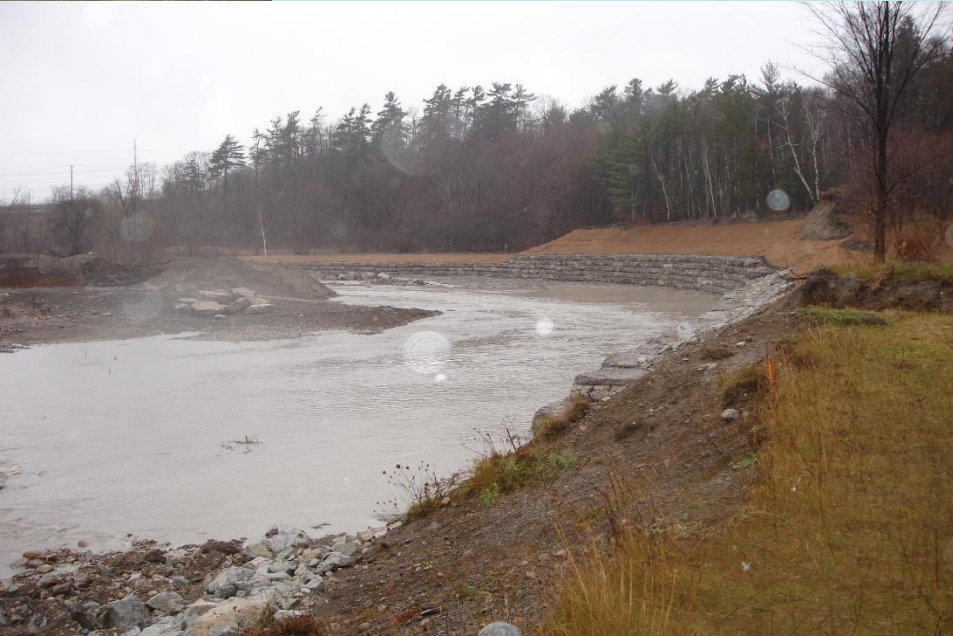
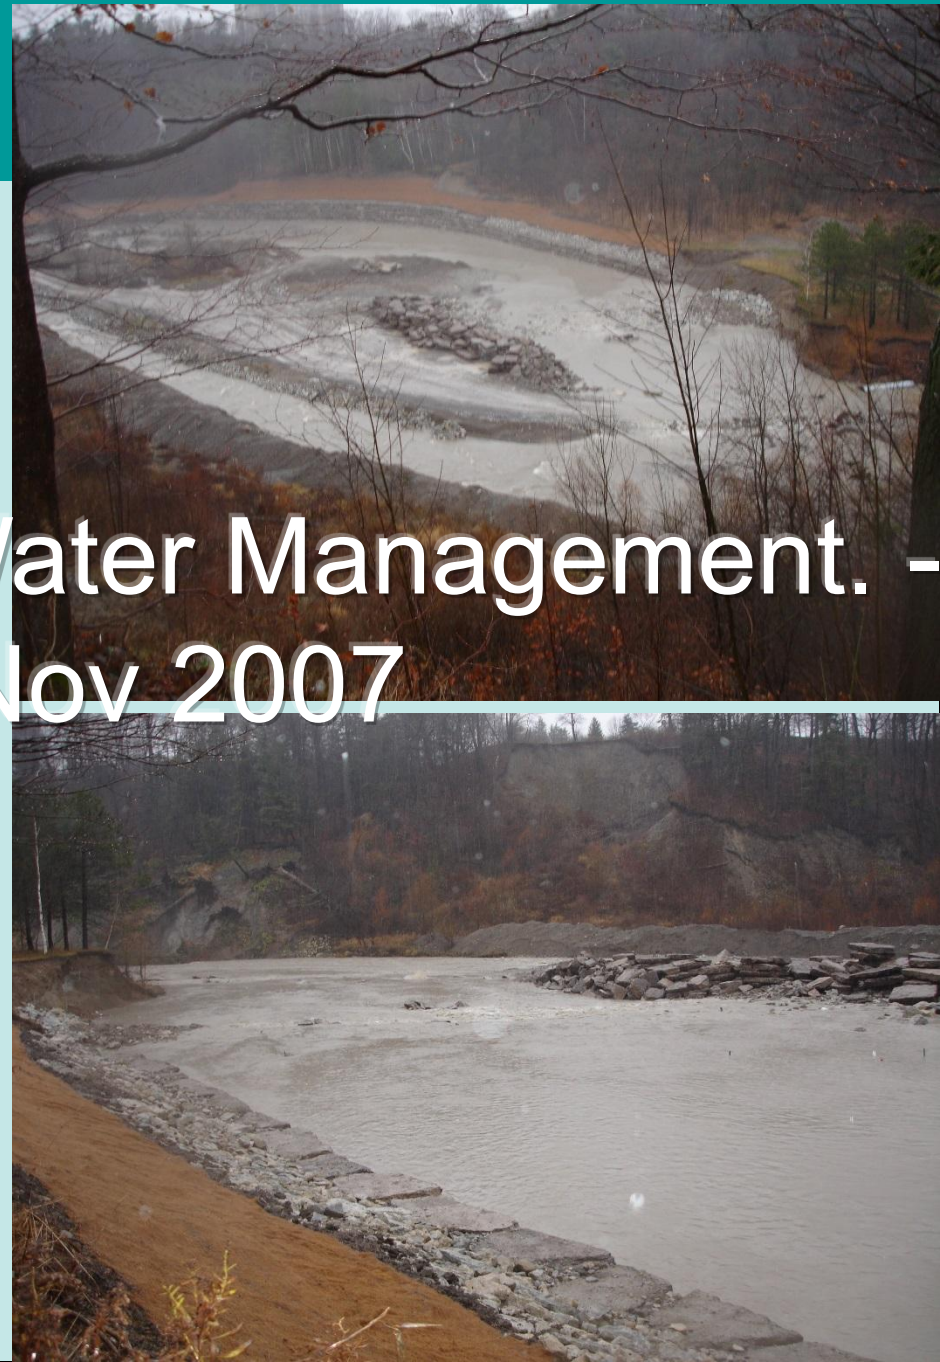
4. Construction & Water Management. - V S 8 Nov 2007

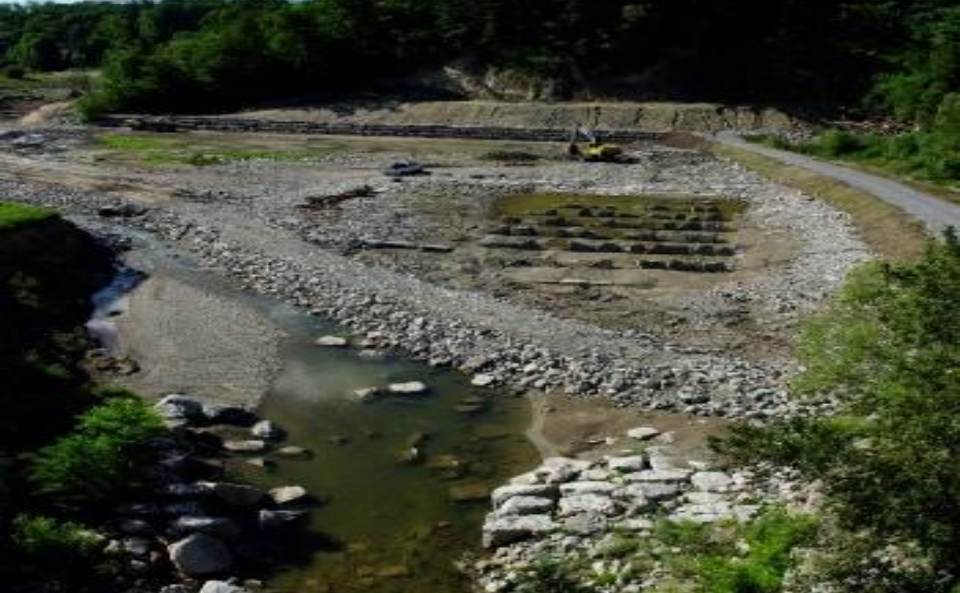
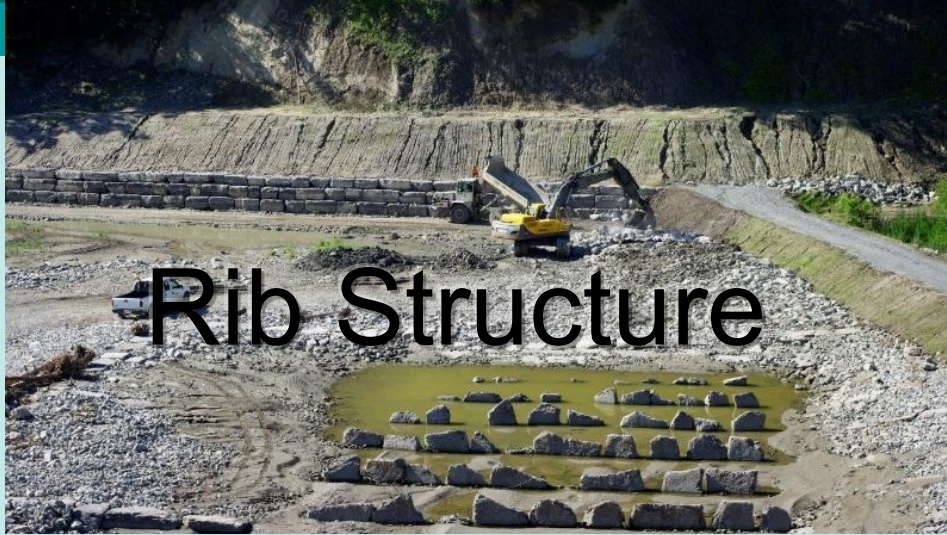
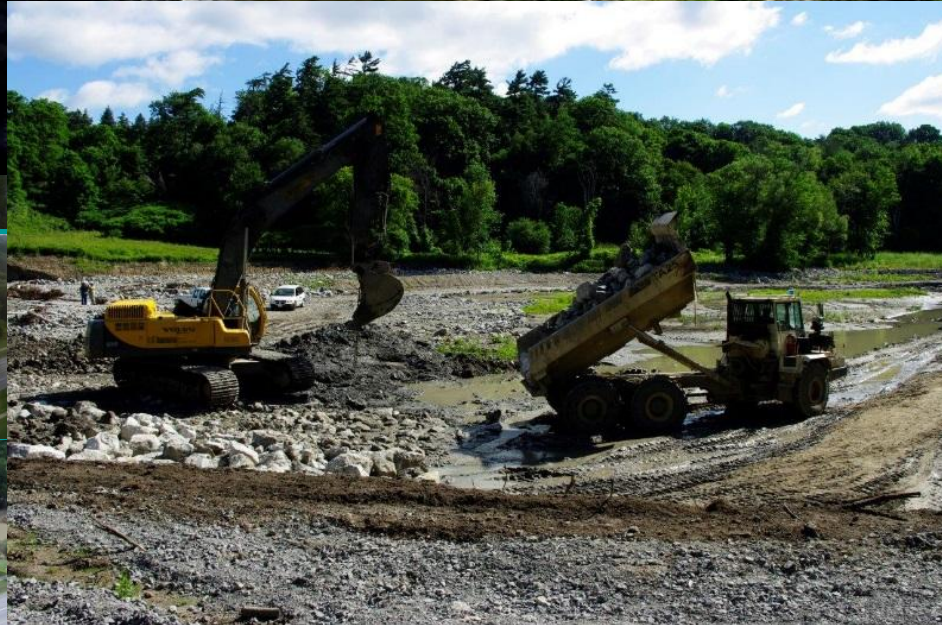
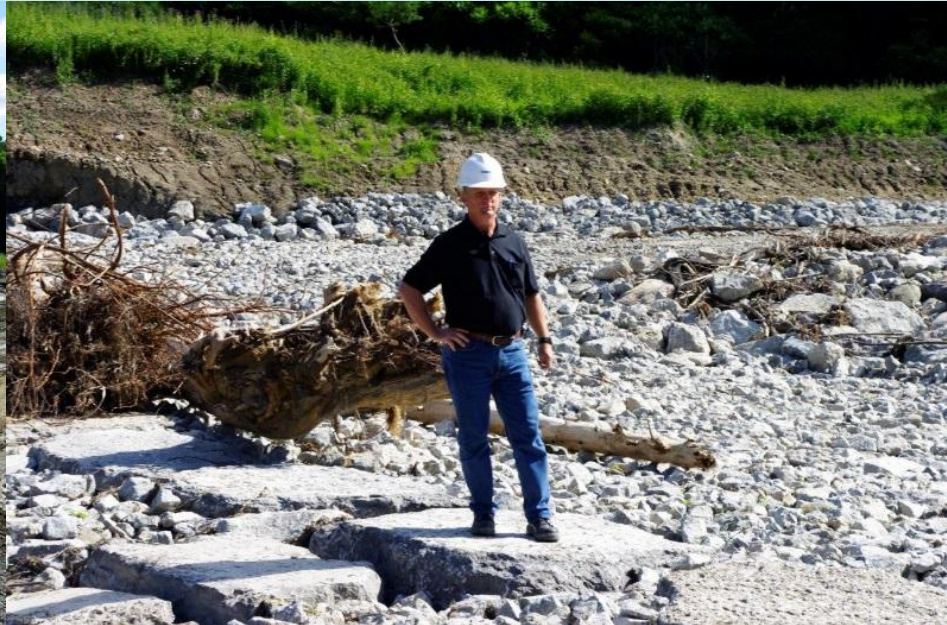
4. Nearing Completion Summer 2008

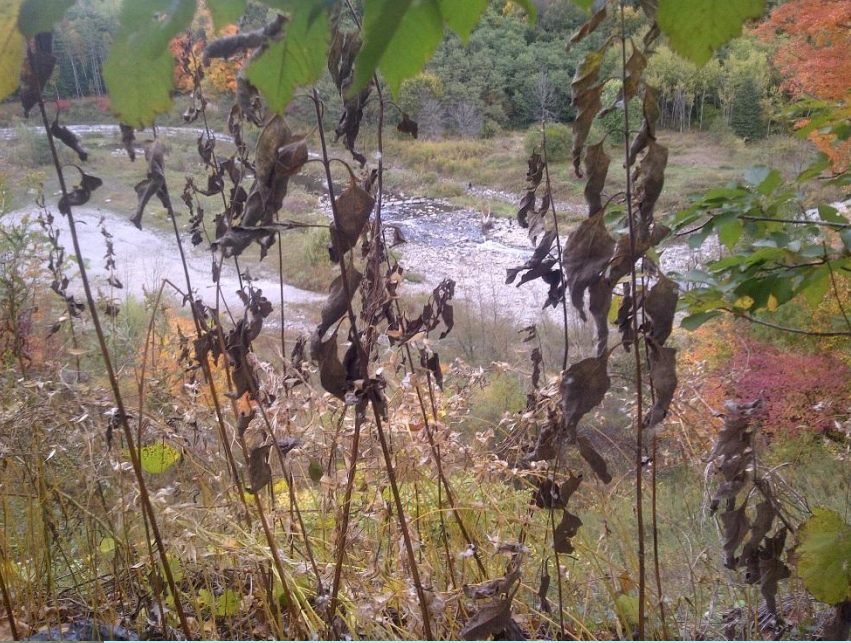
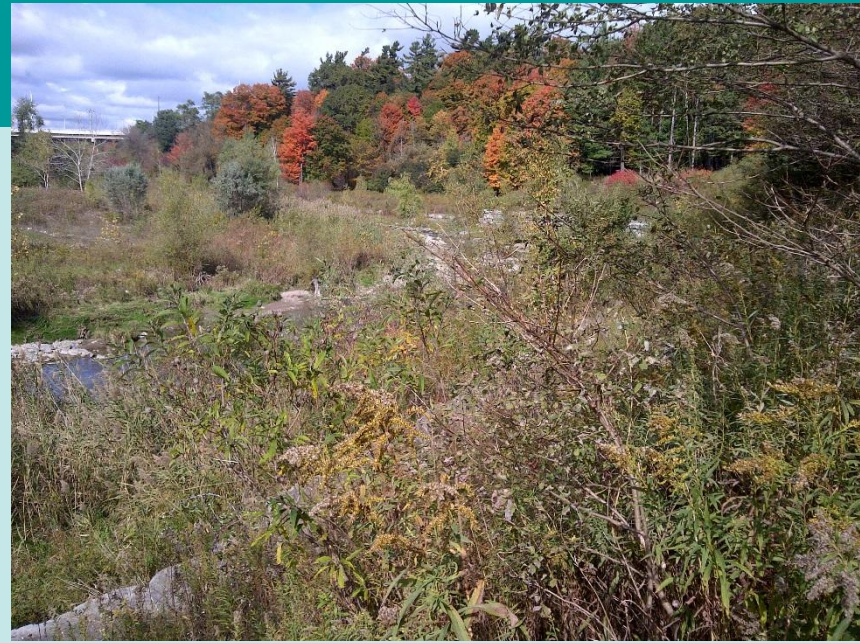
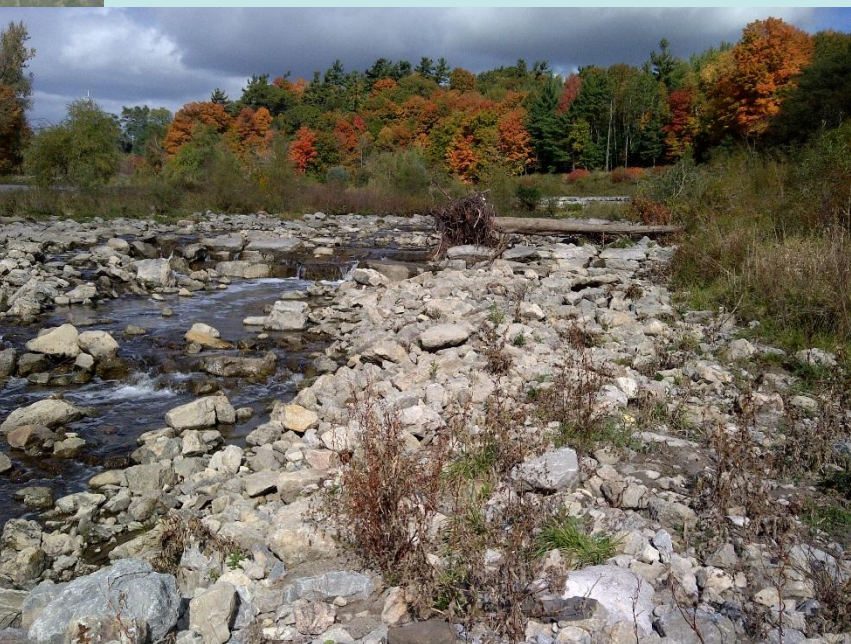
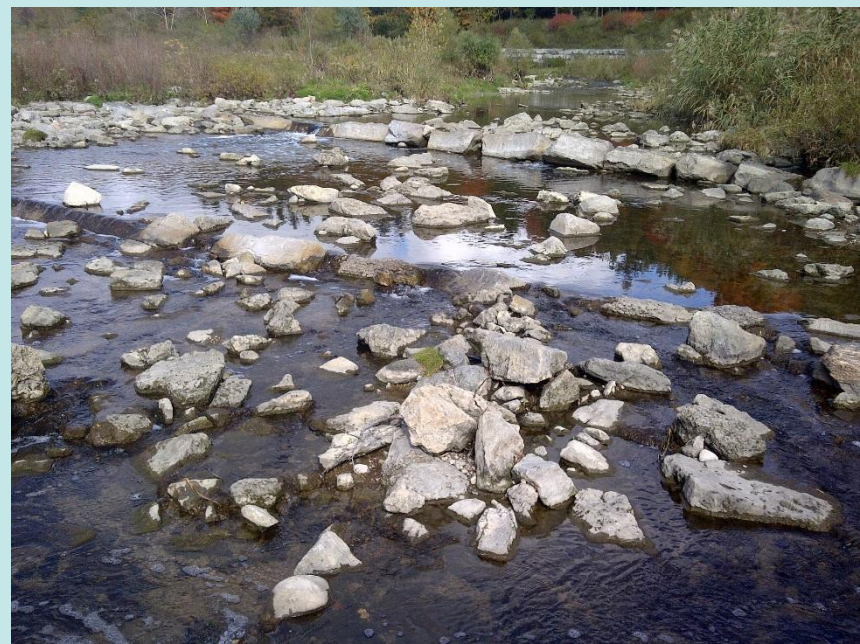
5. Depend on Mother Nature Oct 2015

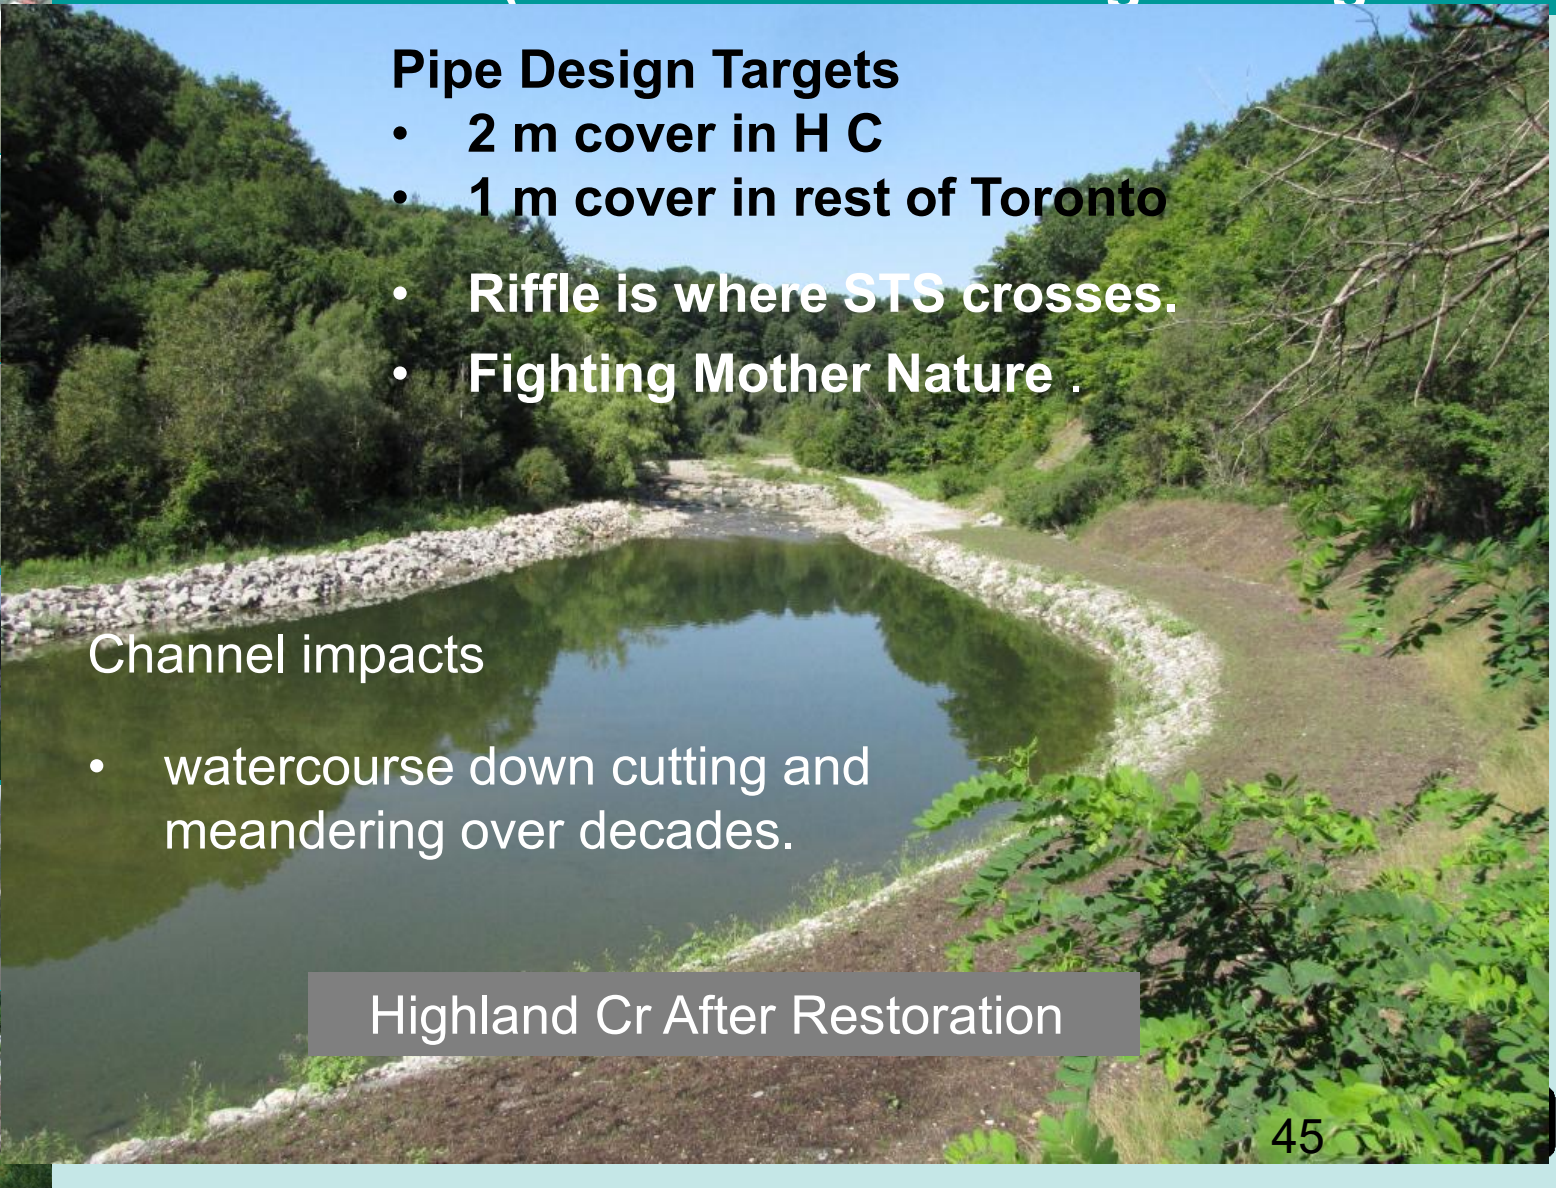
Highland Cr After Restoration

14. Our biggest Challenge- maintain stable riffle (focus for Monitoring 'Design Life')

- 2 m cover in H C
- 1 m cover in rest of Toronto
- Riffle is where STS crosses.
- Fighting Mother Nature .

- watercourse down cutting and meandering over decades.

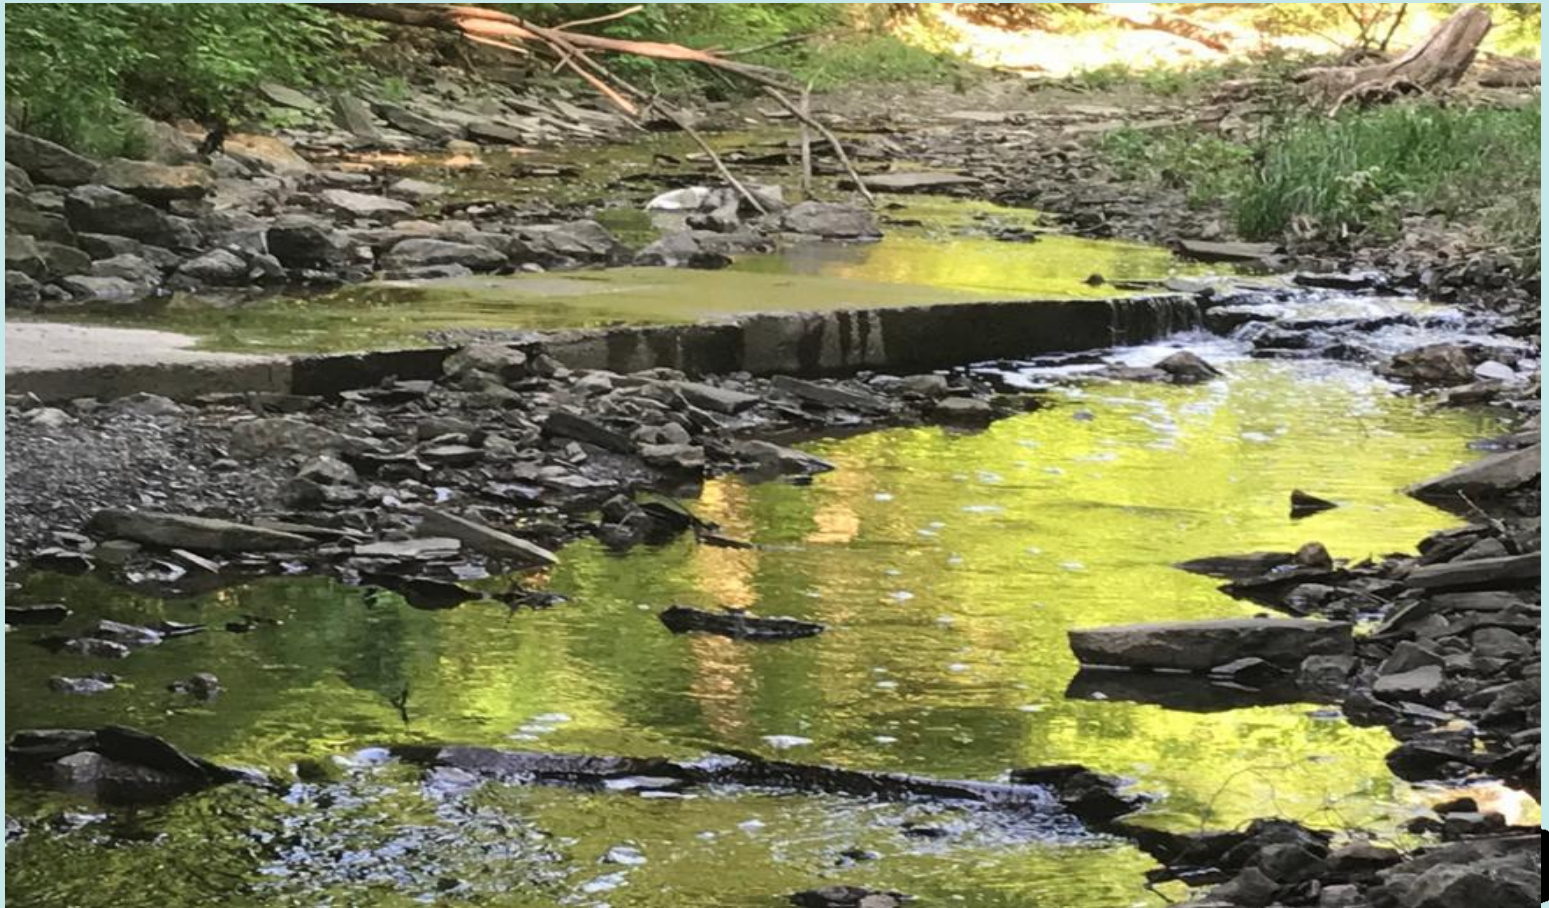
14 Another Challenge – bedrock stream (Georgian bay shales)

- Redox controlled weathering – longer drought conditions=dryer bed)

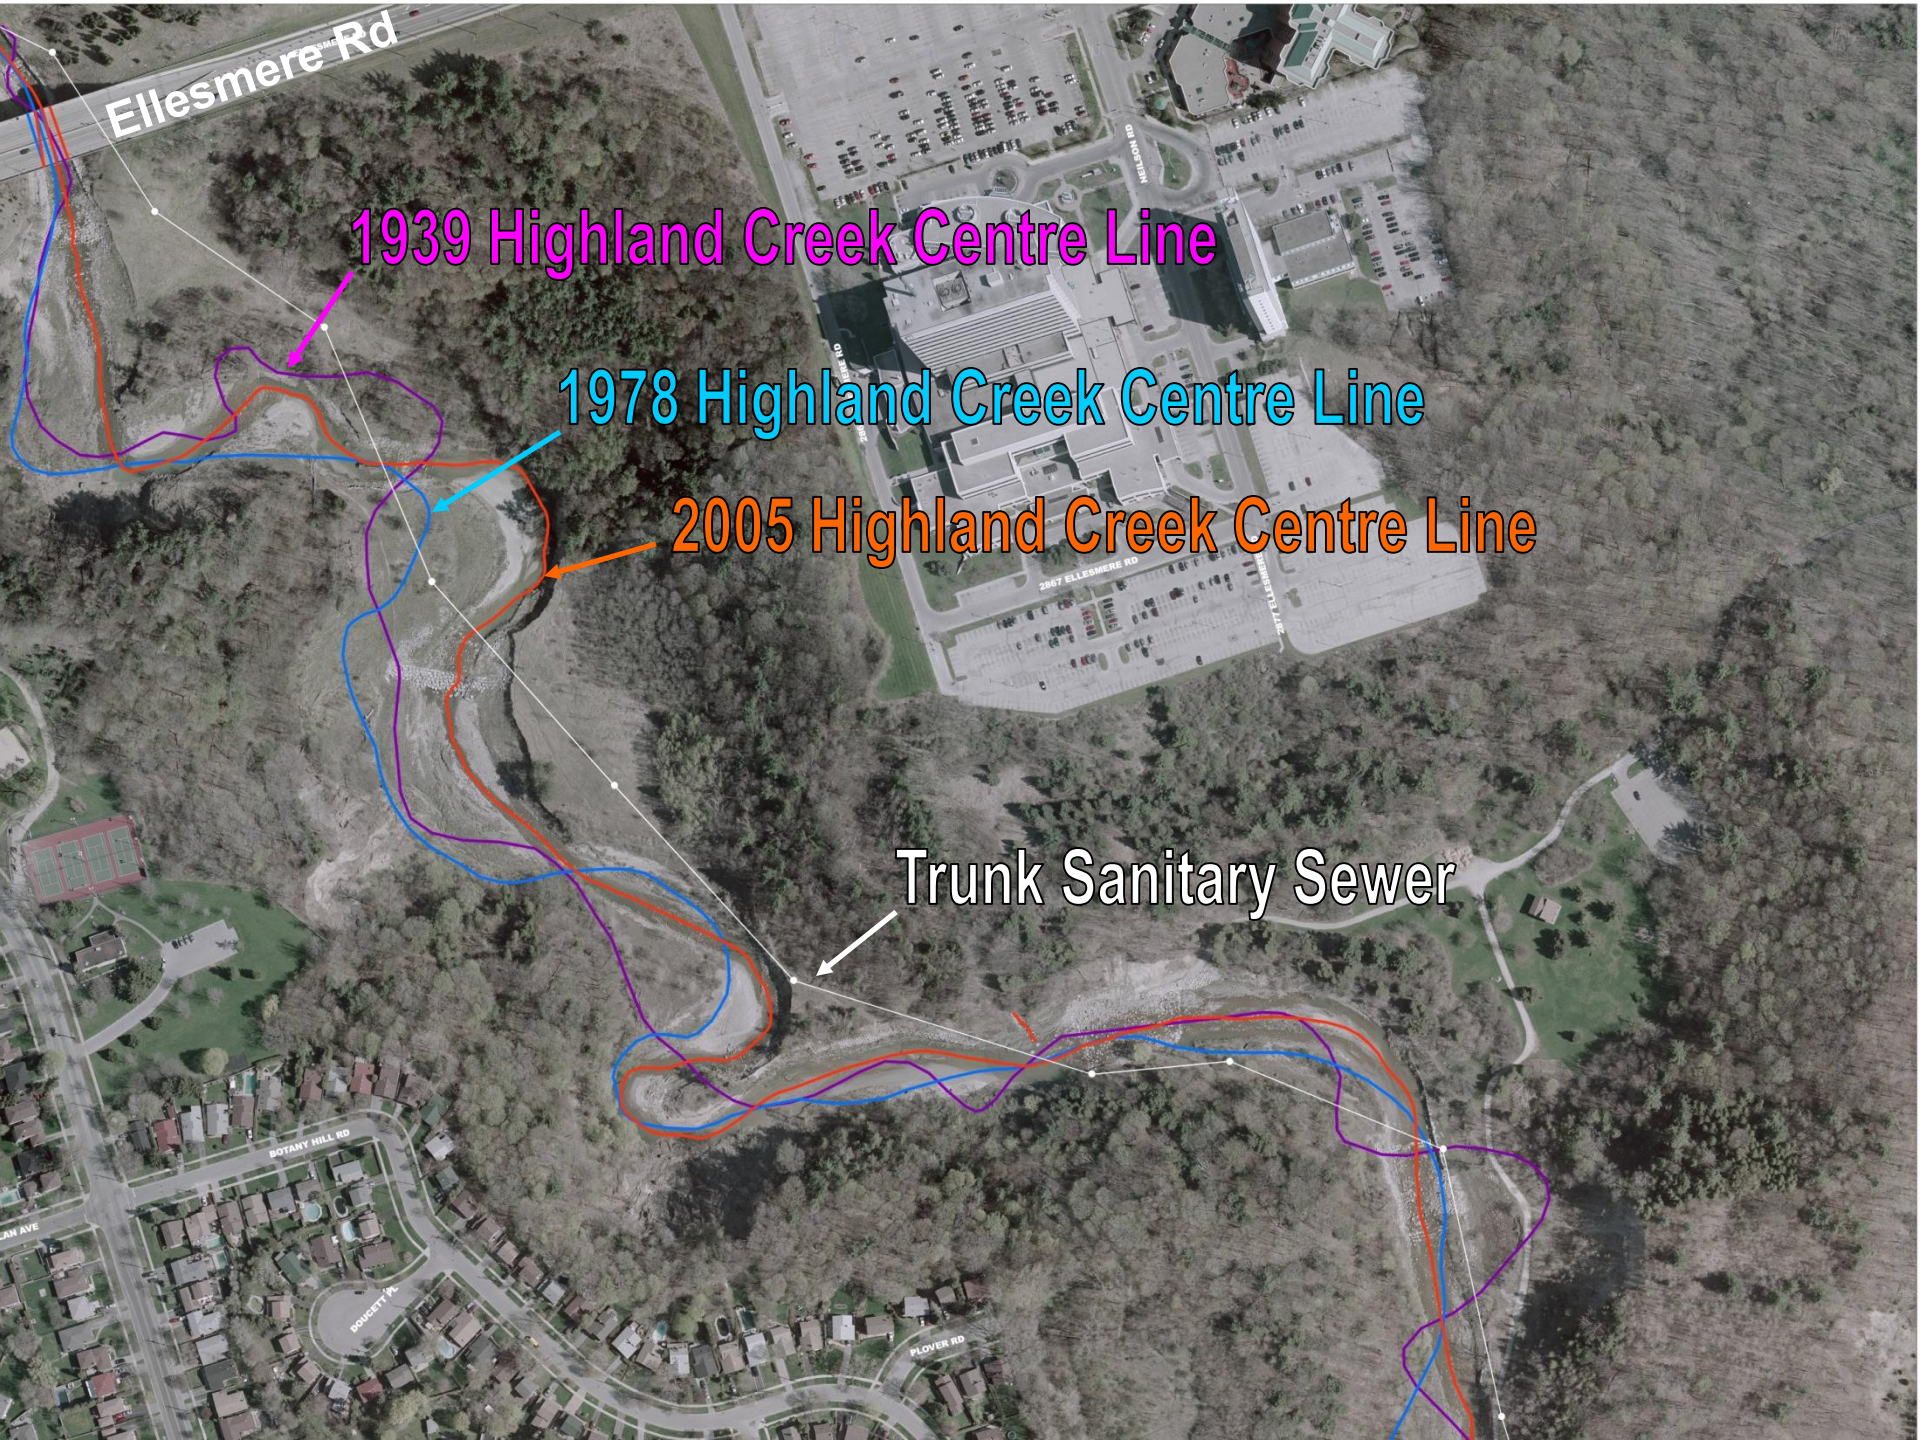
1939 Highland Creek Centre Line

1978 Highland Creek Centre Line

2005 Highland Creek Centre Line

Trunk Sanitary Sewer

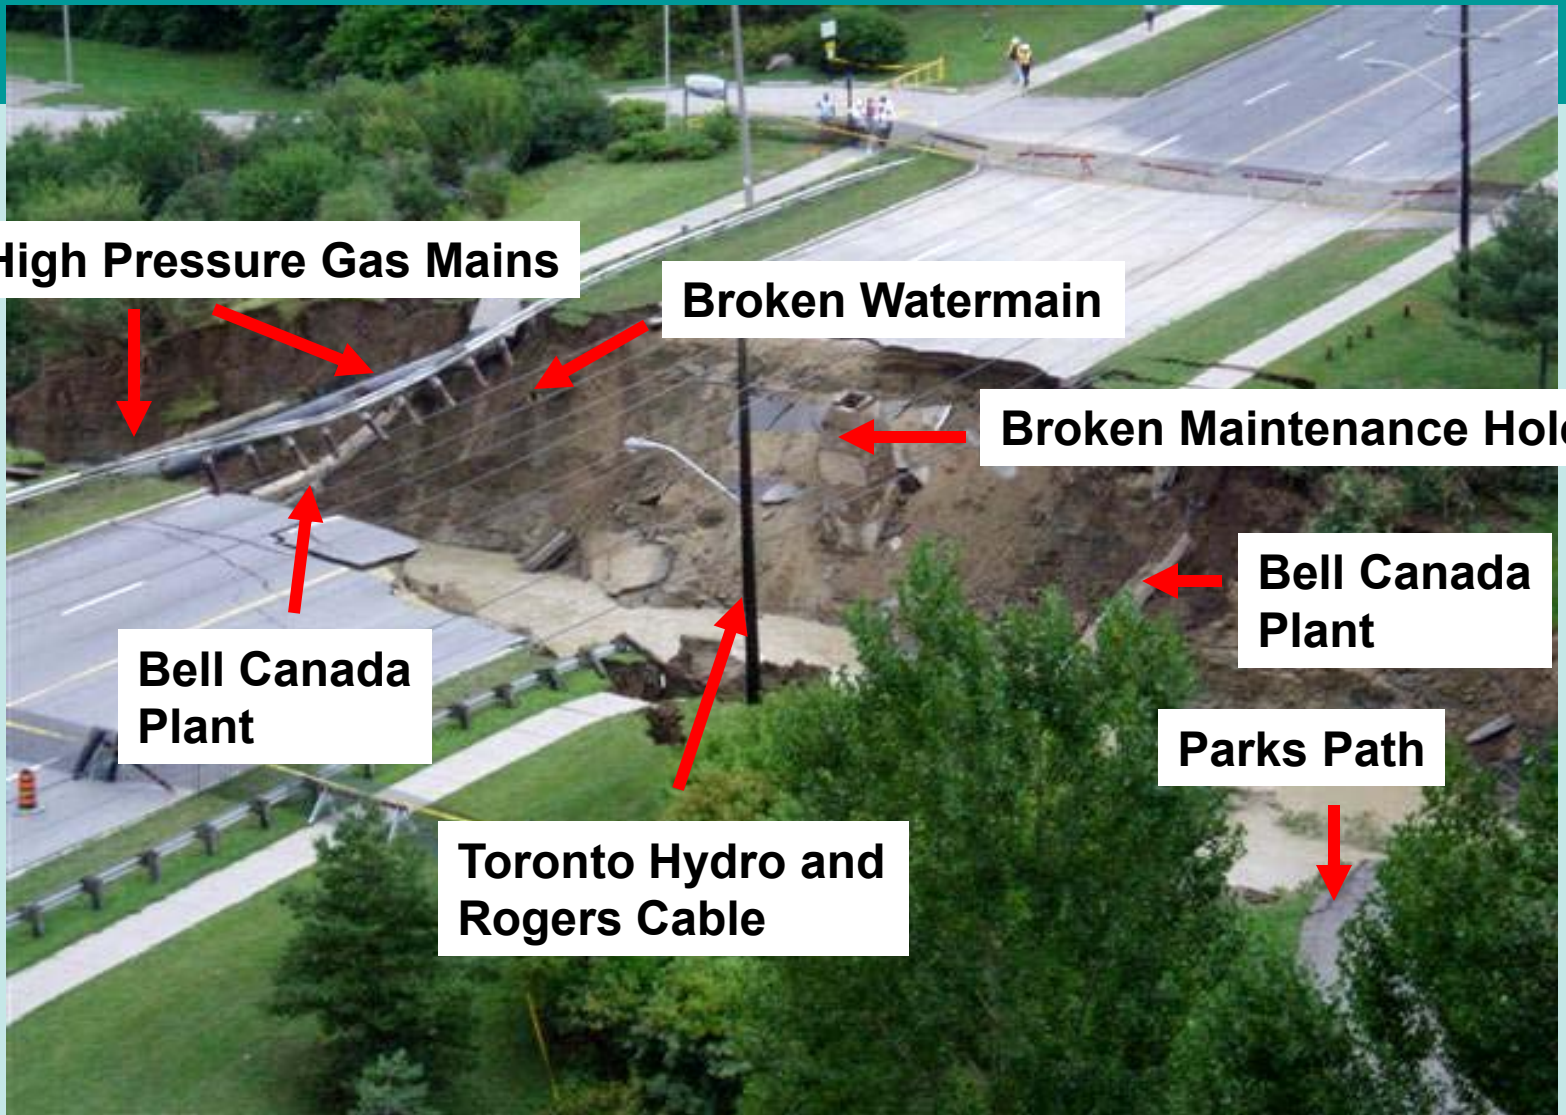
2 High Pressure Gas Mains

Broken Watermain

Broken Maintenance Hole

Bell Canada Plant

Toronto Hydro and Rogers Cable
