LARGESCALE RIVER CORRIDOR RESTORATION: A CASE STUDY OF THE SHEEP RIVER WATERSHED IN SOUTHERN ALBERTA

**PRESENTED BY: LIV HUNDAL (WSP, CALGARY),
GREG COURTICE (APPLIED ECOHYDRAULICS, KELOWNA)**

Presented to Natural Channels Conference | June 2026

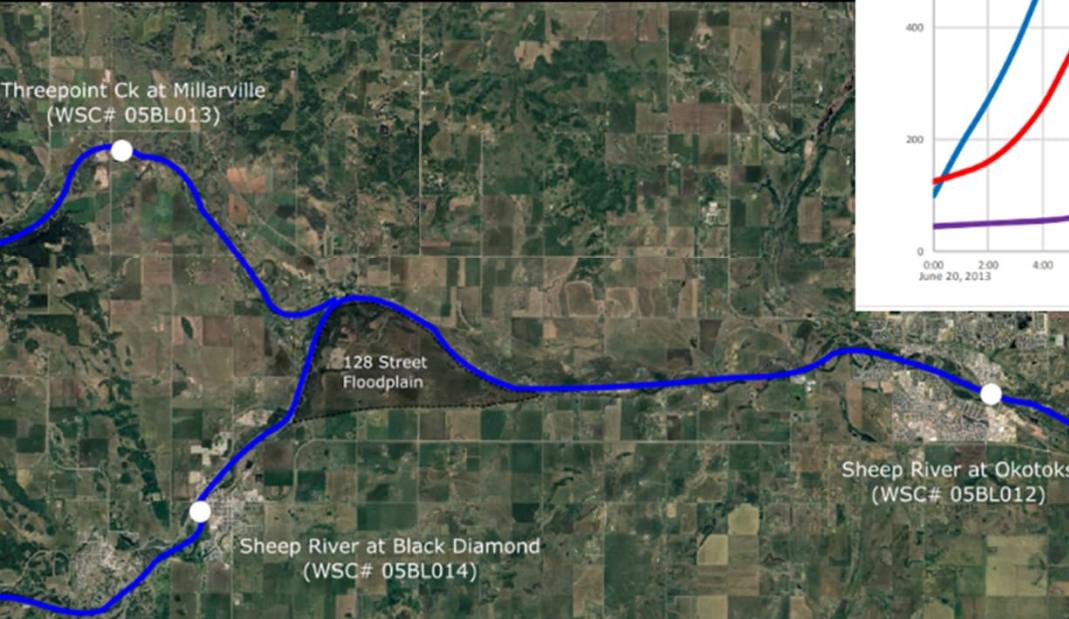
Figure 4.1: Preliminary Estimated 2013 Flood Hydrographs

- Reduced peak flood intensity on Sheep River resulted in less infrastructure damage and a reduction in ecosystem impacts related to channel dynamics
- Maintaining or improving the riparian corridor can help to enhance these benefits

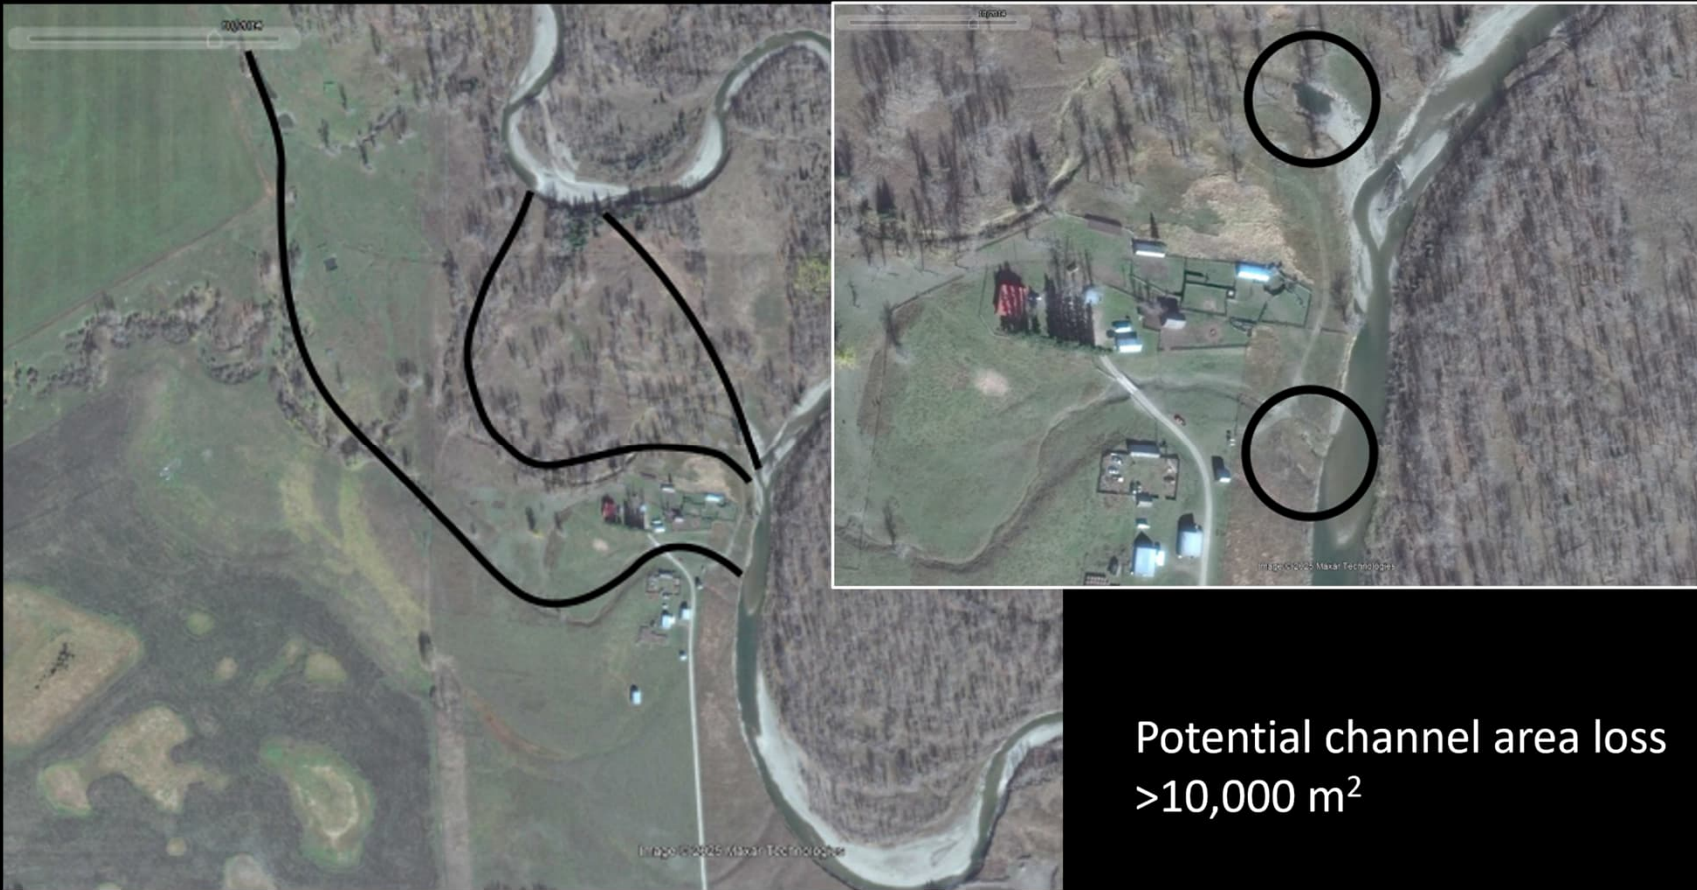
Adaptive Management Building on Lessons Learned

Potential channel area loss
>10,000 m²
