# Sitlika Creek: the Bad, the Ugly and the Really Ugly

Brad Fairley, MES

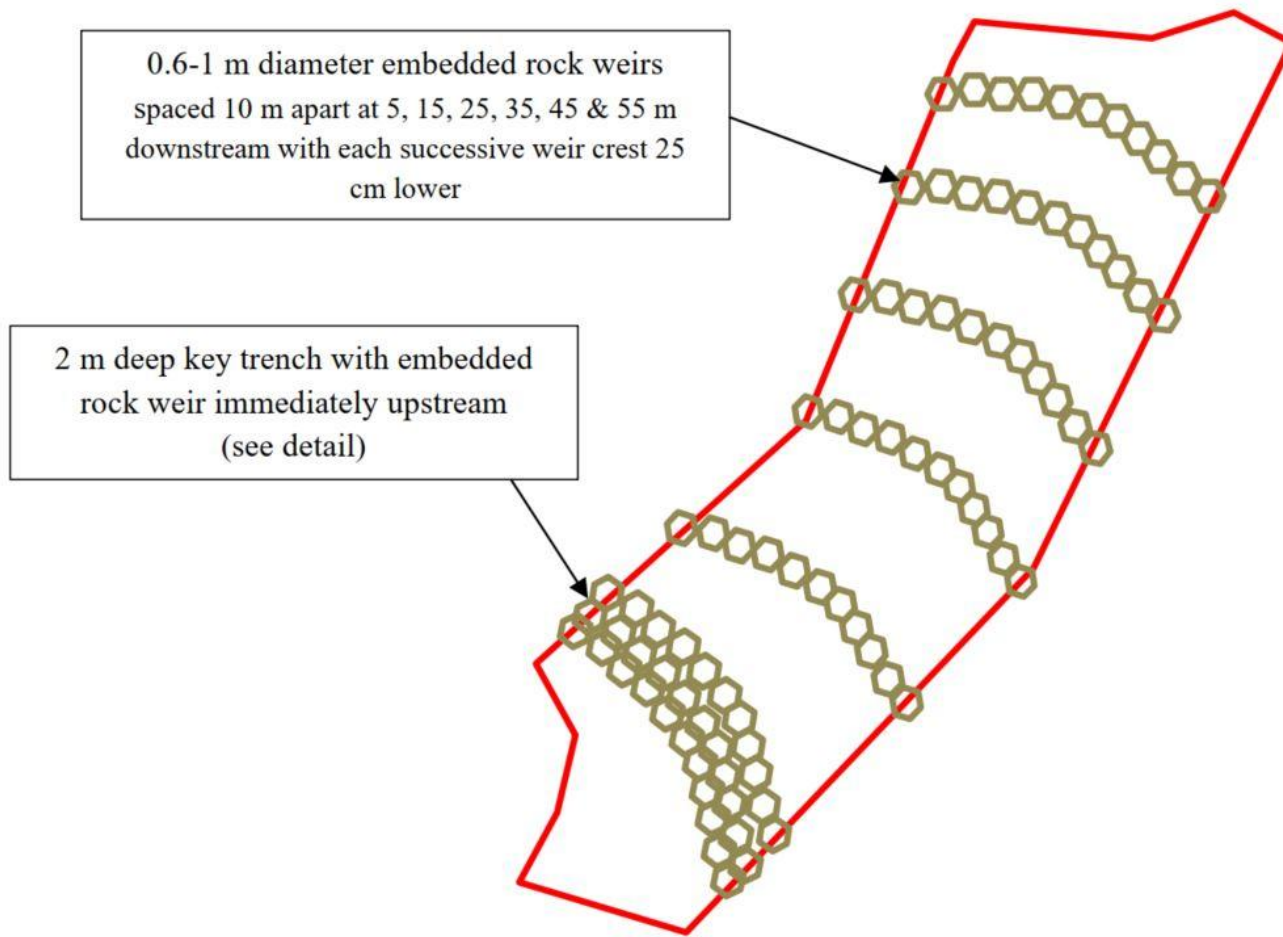
**Plan view general arrangement of new channel.**

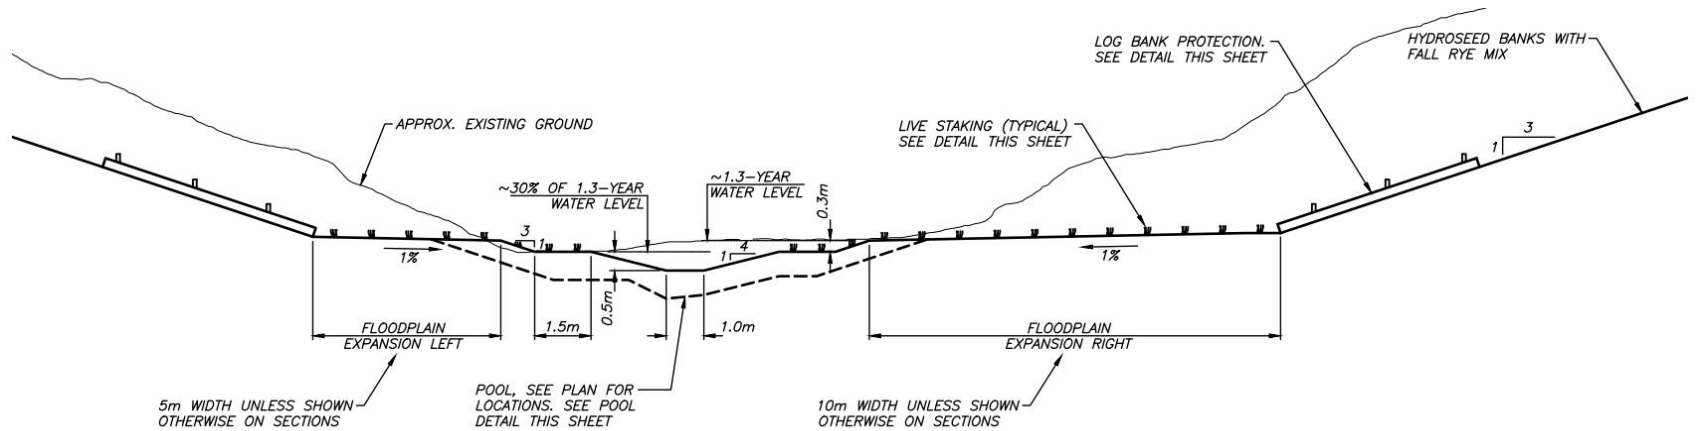
# Design

- RR asked 5SSR to coach the designer
- Improvements
  - Added a floodplain
  - Flattened the slope on the cut through the embankment
- Issues
  - No change in slope / no grade control
  - Channel is too large
  - Nothing to hold TOB
  - Scour on the floodplain
- Conclusion: It would fail if constructed
