Bridges (and more) Over Troubled Water:

Region-Scale Erosion Hazard Screening to Support Municipal Asset Management

8th Conference on Natural Channel Systems | June 8-10, 2026

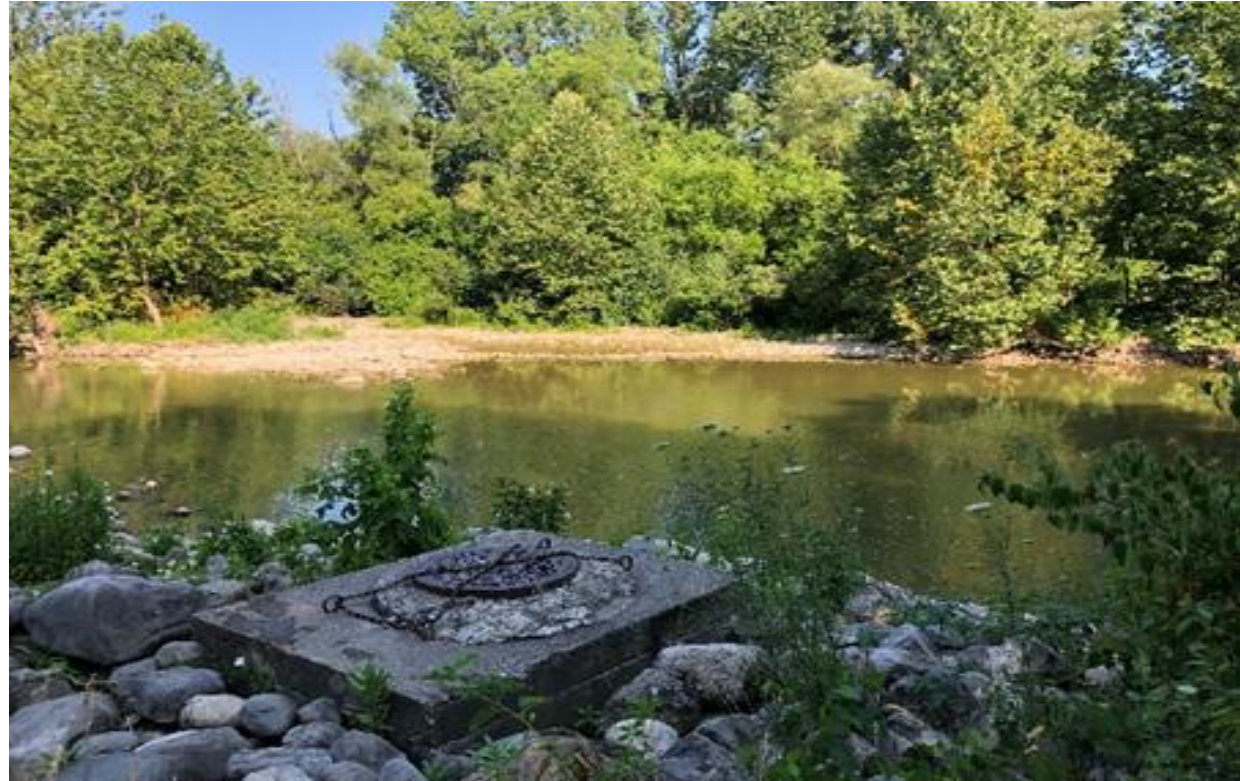
- Site visits to high-priority sites
- Document indicators of erosion and instability
- Results of field assessment inform recommendations

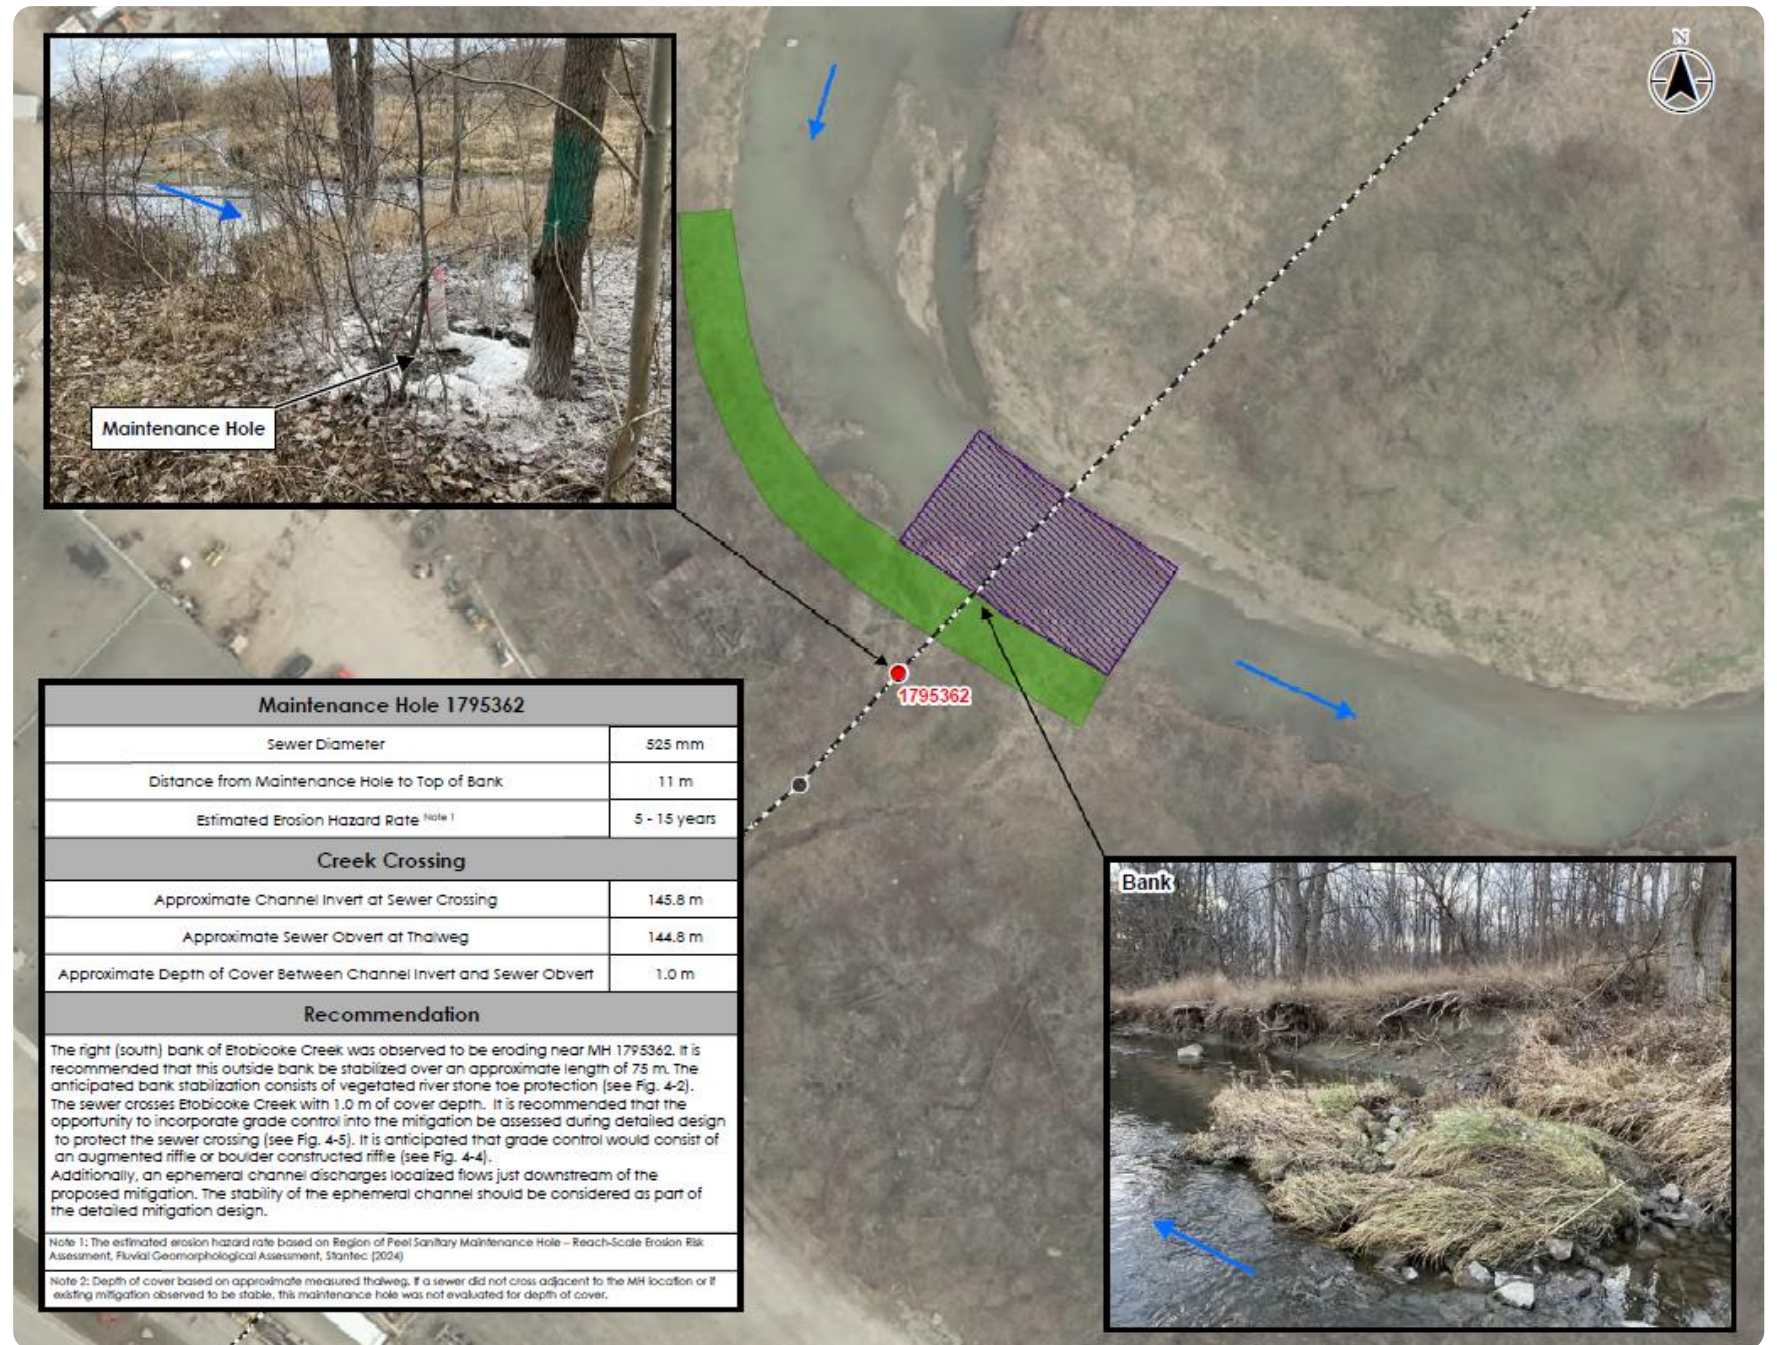
Exposed MH

- Assessment identified MH high risk of erosion
- Shortly after high flow event caused erosion
- Emergency works required to protect infrastructure and environmental
